Pipeline failures due to lightning

P. Venturino^{a,*}, J.N. Booman^b, M.O. Gonzalez^c, J.L. Otegui^d

This article presents experimental studies and conclusions from the analysis of two recent failures that occurred in buried pipelines for distribution of natural gas [6,7]. Both cases occurred in 2012 in Argentina, in steel pipelines with cathodic protection (CP) systems, in a case by sacrificial anodes and in the other with rectifiers and reference electrodes.

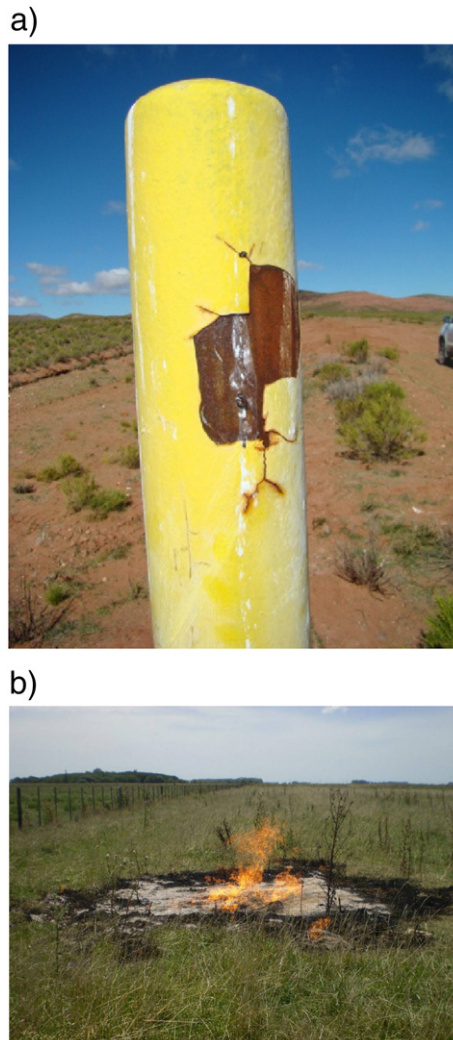
Both failures caused gas leaks followed by fire. Leaks were located at the top of the pipe. The first case (A) corresponds to a pipeline built with a 3 in. (75 mm) dia. SAW (submerged arc welded) seam tubes. The failure occurred on a plain about 3800 m above sea level. The second case refers to a 4 in. (102 mm) 3.2 mm thick pipeline, built with ERW (electric resistance weld) seam,

Fig. 1. a: Molten metal in CP post 30 m away from failure (A), in flat landscape. b: Small fire after failure (B), note flat landscape and nearby wire fence.
