## **Engineering Failure Analysis**

## Failure analysis of corrosion at an inhomogeneous welded joint in a natural gas gathering pipeline considering the combined action of multiple factors

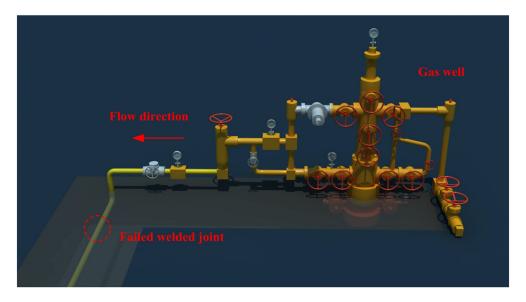
Fig. 1. Location of the failed welded joint in the pipe network.
