# Experimental and numerical studies on corrosion failure of a three-limb pipe in natural gas field

A bursting incident occurred in a three-limb pipe, having 16Mn steel for the main pipe and 316L + L416 composite metal for the branch pipe, in a natural gas field. The failure analysis was performed by means of inspection, experiments and computational fluid dynamics (CFD) simulation. The CFD results indicated the radical change in the flow characteristics inside the three-limb pipe due to its upright structure and the formation of a low vortex in the downstream near the junction, which indicated the condensation of water vapor containing high salinity. The condensed brine saturated with CO<sub>2</sub> adhered to the inner wall surface of the main pipe. In such a corrosive medium, 16Mn steel acts as an anode and is preferentially corroded due to galvanic corrosion. In addition, the downstream area, covered by low vortex, exhibited high shear stress and droplet impingement stress, resulting in an increase in flow erosion. Thus, the failure of the three-limb pipe can be attributed to the synergistic effect of galvanic corrosion and flow erosion.

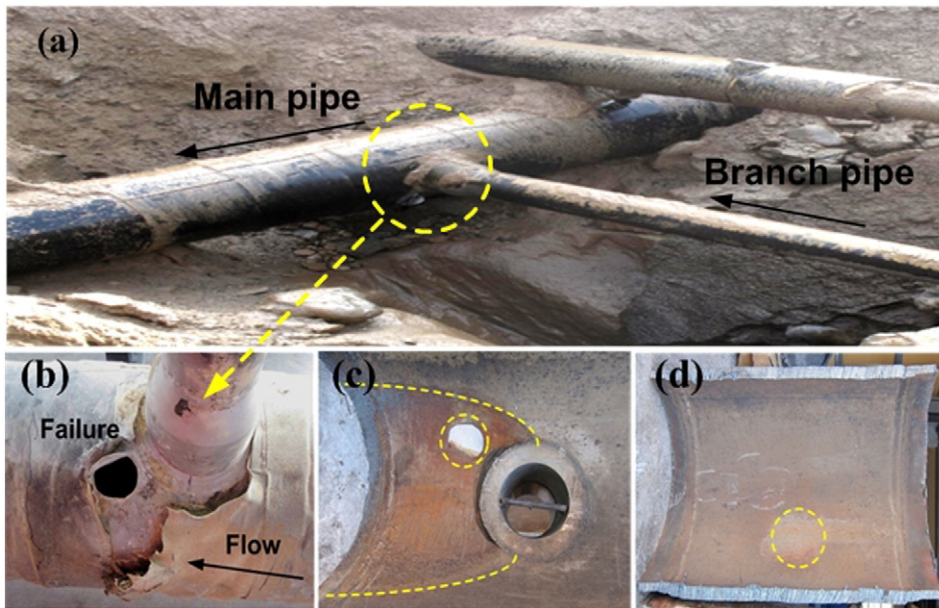
inspections were carried out on the provided physical three-limb pipe specimen. A hole with a diameter of 8 cm was found to be located in the downstream of the failed three-limb pipe and 120° direction of the main pipe, as shown in Fig. 2. The obvious wall thinning area with the feature of hyperbolic shape was observed in the 30°–120° direction of the downstream main pipe near the fillet weld (Fig. 2b, c). However, very little wall thinning was observed on the outside wall surface of the main pipe facing the junction of the branch pipe (Fig. 2d).

Fig. 2. Macro-photographs of failed three-limb pipe: (a) layout of main pipe and branch pipe; (b) bursting failure of three-limb pipe; (c) thinning area with the feature of hyperbolic shape in the downstream main pipe near junction; (d) outside wall surface of main pipe facing the junction.
