Failure investigation of fuel tubes of a jet engine augments assembly

Bokwon Lee ^{a,*}, Ryan L. Karkkainen ^b

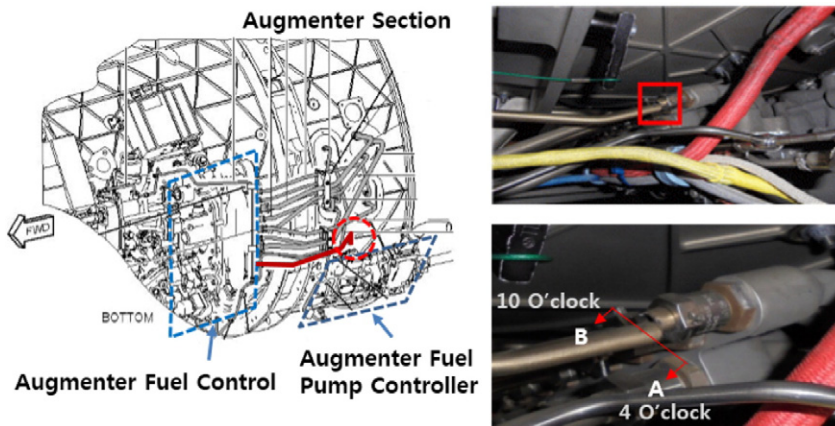
Fig. 1. Attachment location of the failed fuel tube of the augments control system.

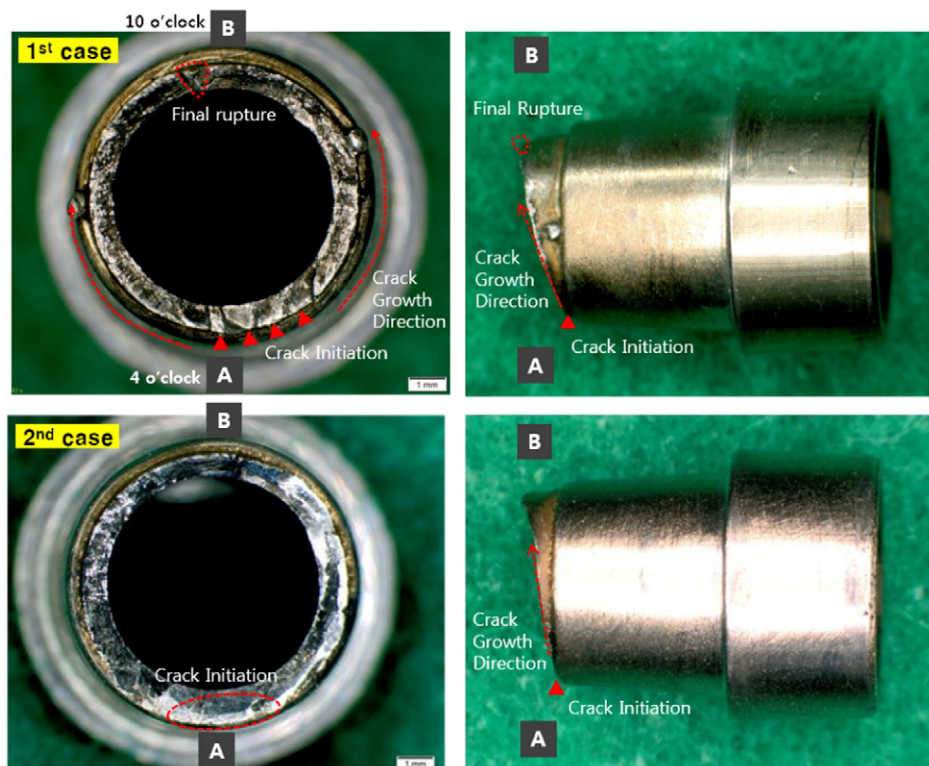
Failure of the fuel tube in a jet engine augments assembly has been investigated. A routine inspection detected that the fuel tube connected to the fuel augments was completely fractured into two pieces in two separate jet engines. Both fractures of the tubes occurred adjacent to a mounting area in the engine augments assembly. Fractographic observation revealed that fatigue cracking was initiated from multiple origins on the outer surface of the tube and progressed over 95% due to fatigue along the circumference, ultimately resulting in fracture. Features of the fractured surfaces in both failed tubes showed almost identical morphologies. X-ray observations showed no evidence of defects in the joint area. 3D scanning technology was employed to precisely measure the tubes, which revealed that both failed tubes had significant dimensional mismatches with the design drawings. Stress analysis including both finite element analysis and X-ray diffraction was used to identify the stress concentration level of the failed tube. Through detailed investigation, it was revealed that the primary reason for premature fatigue cracking of the fuel tube was unintended assembly stress due to the force of mounting the tube during installation.

Fig. 2. Fracture surfaces of the failed tubes.
