# Corrosion induced fatigue failure of railway wheels

Two AAR class B rolled wheels for locomotives failed after about two years of service. The fracture surfaces of the failed railway wheels were examined. The examination showed that there were corrosion pits on the back plate surface of the failed wheels. All of the fracture originated from corrosion pits at the wheel plate surface and fatigue propagated to a length and then expanded rapidly by cleavage. Fatigue specimens cut from the wheel plate were corroded with different time duration in an artificial corrosion environment to simulate the corrosion states of the wheels. The fatigue properties of the un-corroded specimens and the specimens corroded with different times were tested in air. Finite element method (FEM) and Sines' criterion were used to evaluate the safety of the wheels. The results showed that the wheel plates without corrosion pits exhibited an excellent resistance to failure. The corrosion pits could promote the initiation of fatigue cracks and drastically lower the fatigue limits of corroded specimens. The real root cause of the failure of the subject wheels was due to the corrosion pits at the wheel plate su

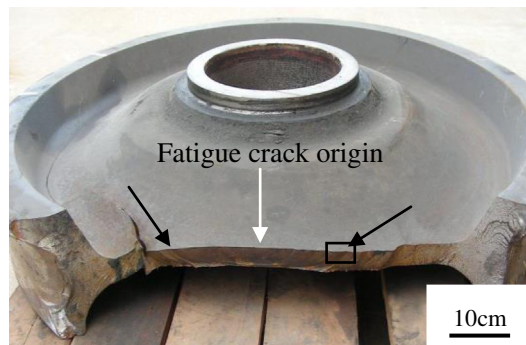
One of the failed wheels (No. 1) as received is shown in Fig. 1. Inspection of the wheel reveals a fatigue crack extended through most of the plate. The extent of fatigue crack is highlighted with the black arrows. Outside the fatigue crack frontier there is the fracture surface caused by abrupt break of the wheel. For more detail, fatigue crack appeared to originate from a surface discontinuity most likely a corrosion pit in the back plate surface and the plate appeared to contain a few more pits, as shown in Fig. 2. The distance from the fatigue crack origin to the center of the wheel is 353 mm.

The fracture surface around the fatigue crack frontier (rectangular box zone in Fig. 1) is shown in Fig. 4. There is an obvious boundary between the fatigue crack and the fracture surface caused by abrupt break of the wheel, as shown in Fig. 4(a). The fatigue crack surface is quasi-cleavage and the fracture surface caused by abrupt break is typical cleavage, as shown in Fig. 4(b).

Fig. 1. The failed wheel No. 1 as received.
