Engineering Failure Analysis

Evidence of gas permeation in electrostatically painted steel cylinders

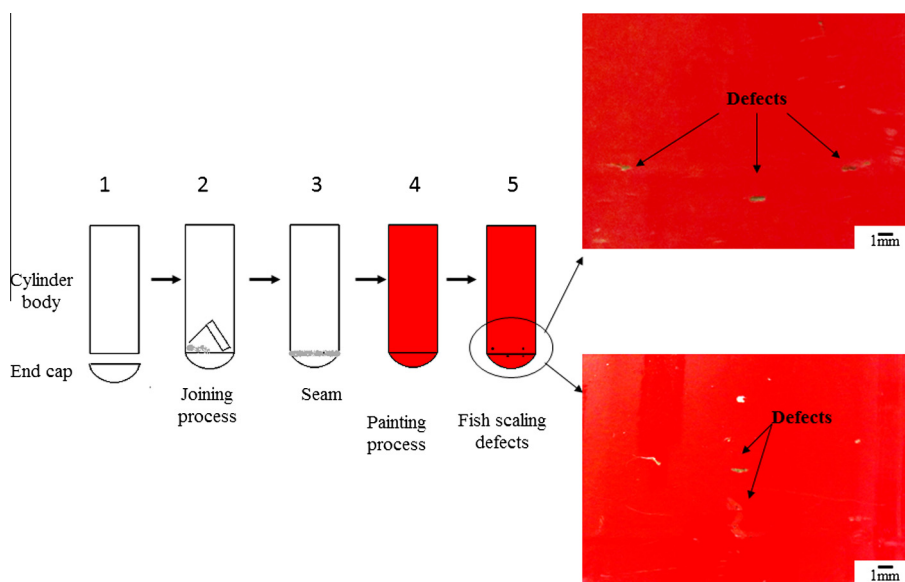
A local manufacturer of fire extinguishers reported the development of surface defects i.e. bumps and pinholes all of them located at exactly the same region on the body of electrostatically painted steel cylinders. An important part of the manufacture route of these items includes welding a round end-cap to the bottom of the cylinder as it is indicated in Fig. 1 then; the items are painted by electrostatic means [21]. After this process, the defects appeared on the surface of the specimens exactly at the opposite region of the heat-affected zone formed during the welding process (Fig. 1). Development of defects in these items is unacceptable given that they could promote water entrapment at the interface coating-steel, causing pitting of the metal.

Fig. 1. Schematic representation of the process route and photographs of the defects found on the surface of the cylinders.
