Study of the failure of one machining tool

A.M. Irisarri, E. Silveira *

INASMET – Tecnalia, Mikeletegi Pasealekua 2, 2009 San Sebastian, Spain

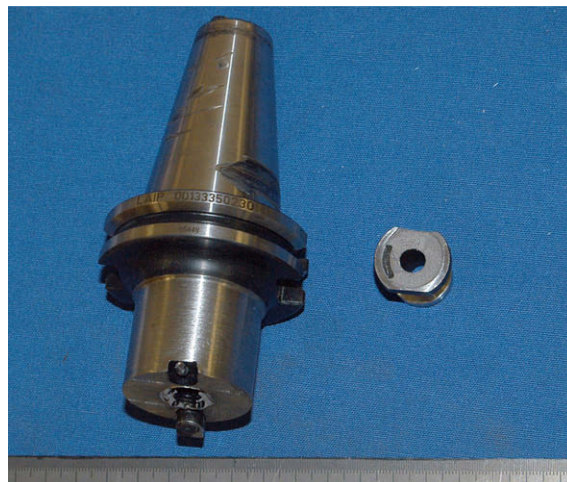
Visual examination of the fracture surfaces pointed towards a fracture of brittle morphology, in good agreement with the sudden and premature failure. Both, the naked eye examination and that more detailed, performed with the help of the stereoscopic microscope, revealed the presence of a marked notch, darker than the remaining fracture surface, sited on the left hand side of Fig. 2. The morphology of this notch points towards the machining of the section change of the tool existing at that point, with an accentuated neck, clearly visible in Fig. 3, which presents a lateral view of the two halves of the tool. From this origin the crack grew circumferentially until the sudden failure of the tool was induced when the unbroken ligament was not able for withstanding the loads applied on it. Fig. 4 presents schematically the whole failure process while in figure, can be observed the necking of the tool in this zone.

Fig. 1. General view of the two pieces of the failed tool.
