Analysis of the factors involved in failure of a brass sleeve mounted on an electro-valve

Several electro-valves have failed because of the fracture occurred on the internal sleeve made in a typical free cutting leaded brass CW614 N (UNS 36000). The morphology of the observed fracture surface clearly indicates that the failure phenomenon has been ruled by a stress corrosion cracking mechanism. On the other hand, all the electro-valves operate in an environment featured by potable water that does not justify an alkaline concentration able to induce the SCC phenomenon. The analysis of the observed surface and the comparison of the stress that can induce SCC clearly point out that the failure has been induced by the application of excessive torque on the threaded sleeves to grant their fixing. The performed investigation allows us to indicate the correct procedure in order to avoid the failure of the sleeves and also the change of the applied alloy or an excessive increase of the resistant thickness of such a component.

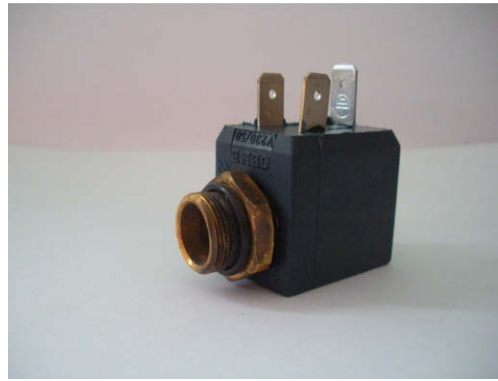
Some typical electro-valves are constituted by a core where a sleeve is located within the inducing coil. This sleeve assures the correct sliding of an internal mobile stopper activated by an electromagnetic field (Fig. 1).

Fig. 1. An example of a whole electro-valve with the threaded brass sleeve.

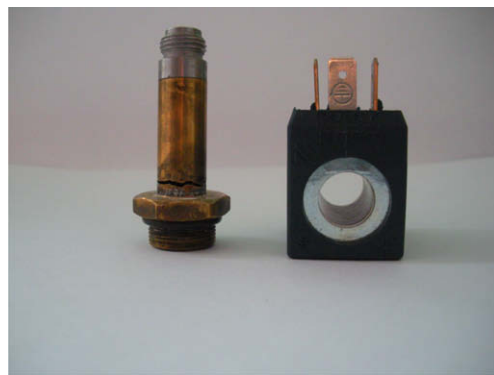
The electro-valves equipped with a brass sleeve are generally used for the application in the distribution network of the drinking potable water. On the other hand, some failure cases have taken place in this environment and they are caused by the fracture of the inner sleeve (Fig. 2). The sleeve is forced within the hole through the bolt applied on the upper threaded extreme.

Fig. 2. Example of a fractured sleeve mounted on an electro-valve.
