Plastic collapse of a stainless steel pressurized tube

The failure of a stainless steel tube which conducted oil at 300 °C has been analysed. The fracture surface of the broken tube was studied in the scanning electron microscope and the fracture mechanism found was the nucleation, growth and coalescence of voids. This mechanism is characteristic in materials plastically deformed before failure. Specimens for metallographic examination were cut from the damaged tube and from an intact tube to analyse both microstructures. No significant changes which could justify a microstructure's embrittlement were detected. Hardness measurements were performed on the damaged and intact tubes. The broken tube was harder than the intact tube due to plastic deformation accumulated during failure. The pressure which is necessary to reach this hardening was analysed by the deformation theory of plasticity and it was found this pressure is close to that corresponding to the plastic instability. Consequently, the most plausible hypothesis of failure was due to an over-pressure which leads to the tube's plastic collapse.

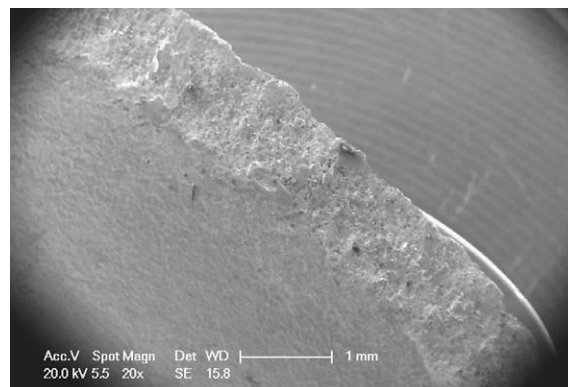
The fracture surface of the broken tube was analysed by SEM. A low magnification image of the broken surface is presented in Fig. 1 showing a ductile fracture micromechanism [1]. Higher magnification images, along the tube thickness, are presented in Fig. 2. Fracture was initiated at the internal side of the tube and was propagated through the thickness until failure by a mixture of nucleation, growth and coalescence of voids and a tearing mechanism promoted by the small thickness of the tube. These fracture mechanisms are usually observed in materials plastically deformed before fracture. Features which could indicate neither an embrittlement of the stainless steel nor the presence of critical defects were found. Ti (C, N) precipitates were observed through the fracture surface like the one showed in Fig. 3, which are distributed along the material's microstructure as it will be discussed in the following section.

Fig. 1. Fracture surface of the broken tube at low magnification.
