Cause and effect assessment after a complex failure of a large ethylene compressor

P.G. Fazzini¹, A.A. Márquez², J.L. Otegui^{*}, P. Barcia³

Abstract

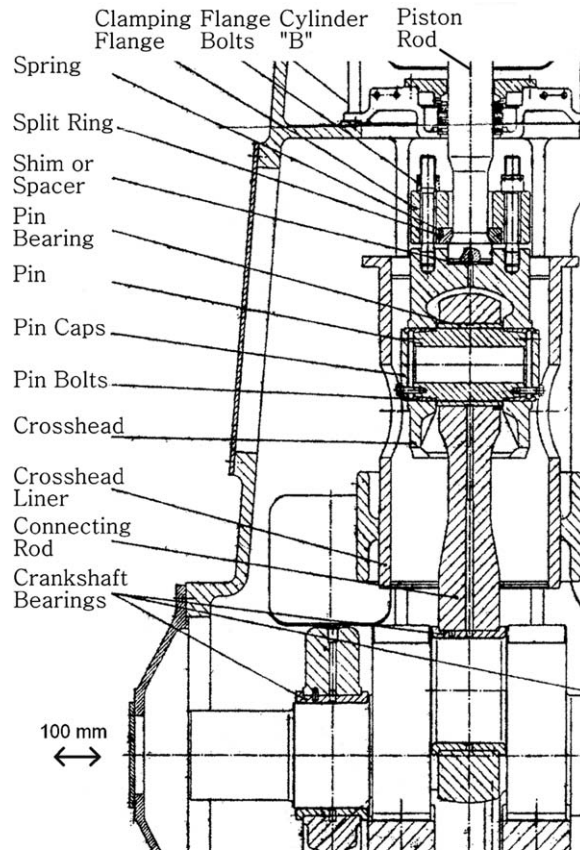
Fig. 1. Diagram of parts related to the failed crosshead of cylinder B. comp. C111.

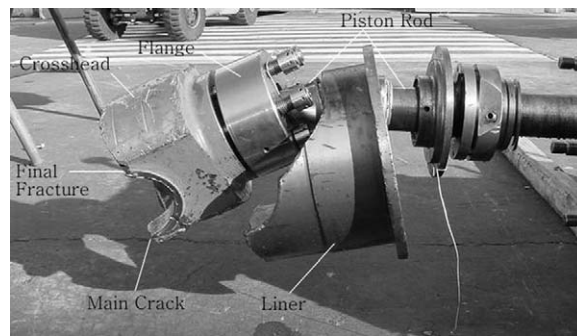
Fig. 2. Massive damage to crankcase and other parts.

of cylinder B) provoked massive damage to crankcase and other parts, these can be seen after disassembly in Fig. 2.
