Case study

Analysis of a failed rocker arm shaft of a passenger car engine

G.A. Nassef^a, A. Elkhatib^a, Mostafa Yakout^{b,*}^a Department of Production Engineering, Alexandria University, Alexandria 21544, Egypt^b Department of Mechanical Engineering, McMaster University, Hamilton, ON, Canada L8S 4L7

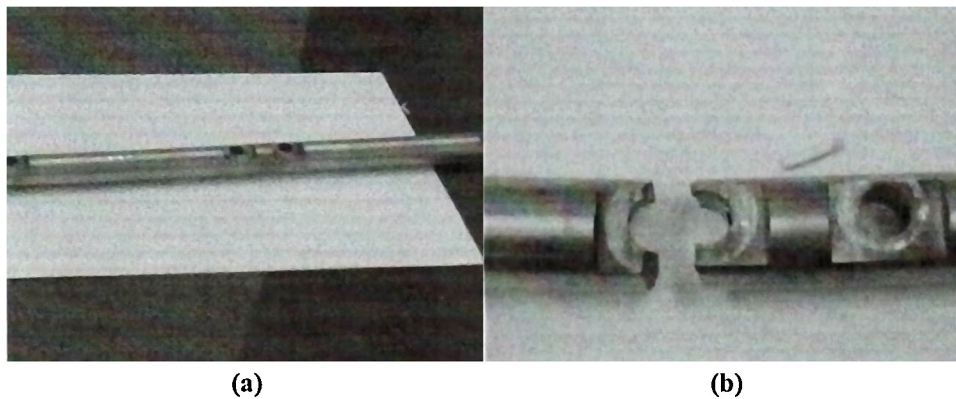
This paper investigates the failure of a rocker arm shaft of a passenger car. The shaft failed by brittle fracture across one of the four holes supporting the shaft into the cylinder head. The running distance of the engine just before failure was 40,626 km. Visual examinations of etched sections of the failed shaft and a *new one* revealed four distinct zones of darker etching appearance. These zones correspond to the four locations where the rocker arms fit the shaft.

Microscopic investigations of the failed shaft revealed the presence of microcracks close to the supporting holes. These cracks may have been induced in the shaft by the non-uniform cooling during quenching in the course of heat treatment, or may be nucleated by repeated loading during service. This premature failure has occurred by the rapid crack propagation because of the lower fracture toughness of the martensite.

Suddenly during the start-up of a passenger car engine, a high abnormal noise accompanied by a jerky vibration of the engine had been manifested. After dismantling, the local dealer service found that the rocker arm is broken near the middle as shown in Fig. 1(a). The fracture passes across the hole of one of the supporting bolts as shown in Fig. 1(b). Visual examination of the car engine showed that the running distance of the engine just before failure was 40,626 km during which regular services had been given to the engine as recommended by the manufacturer's manual.

Fig. 1. Photograph of the failed rocker arm shaft.
