## Case study

## Fracture analysis of a low pressure steam turbine blade

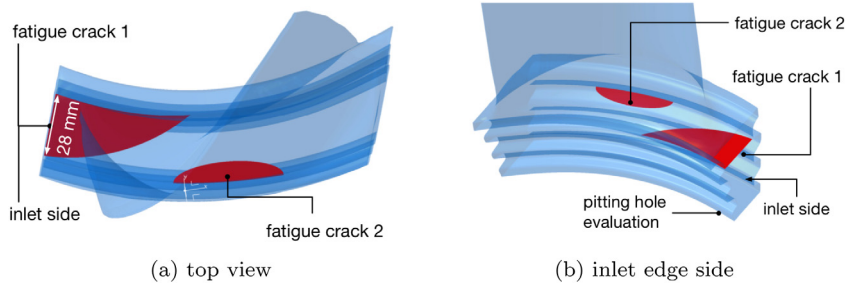
Linear elastic fracture mechanics (LEFM) and FEA are typically used for damage tolerance or fail-safe design concepts (e.g. the evaluation of the residual life-time with the Paris law or the leak-before-break design) as illustrated by [6, p. 378]. Here LEFM and FEA are used to evaluate stresses in order to suggest the crack initiation, propagation and finally the operating conditions. Results from failure analysis with literature data are used as an input for the fracture mechanics analysis. Knowing three of the parameters in Fig. 1a (e.g.  $Y$ ,  $a$ ,  $\Delta K$ ) the fourth ( $\Delta\sigma$ ) can be calculated. FEA and determined input parameters (see Fig. 1b) are used as a proof and as an extension to the analysis. The cracks are illustrated in Fig. 2 to show the investigated turbine blade in top Fig. 2a and side Fig. 2b view. The red planes at the first load bearing flank mark the positions of the fatigue cracks. Crack 1 is the oldest fatigue crack and is therefore used for analysis.

Fig. 2. The fatigue cracks are illustrated with red planes at the pressure (crack 1) and the suction side (crack 2) of the blade. (For interpretation of the references to colour in this figure legend, the reader is referred to the web version of the article.)

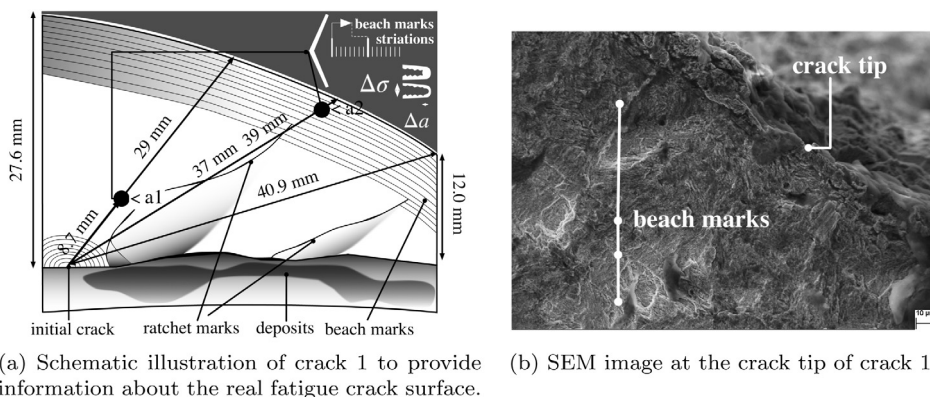
Crack growth can generally be divided into three stages [7,8] as to the crack propagation curve – though more detailed distinctions are possible [9]. Stage I is related to crack nucleation or crack initiation, stage II to constant fatigue crack growth and stage III is related to failure by fracture, instability or an other limiting factor. Crack initiation within stage I occurred by pitting corrosion at the first load bearing flank. To investigate the fracture surface in stage II, the apparent beach and ratchet marks of crack 1 were analysed and are illustrated in Fig. 3. The cyclic stress amplitude and/or load ratios relates to beach mark and striation formation [9, pp. 530], which is aka similitude hypothesis [10]. Fig. 3a shows the traced fracture surface image of crack 1 and displays the path of the crack like a roadmap, beginning from the pitting hole (initial crack) towards ratchet marks (local crack surfaces join each other) to the crack tip. The shape of the fracture surface is elliptical with a final relationship between the short arm  $a$ , and the long arm  $c$  (along the 1st load bearing flank), where  $a = 27.6 \text{ mm} / c = 43.4 \text{ mm} = 0.64$ . The striations, separating different beach marks are not visible without the use of a scanning electron microscope (SEM). The positions for the evaluation of the striation distances are marked at the fracture surface with  $a_1$  and  $a_2$ . The SEM image in Fig. 3b shows beach marks (indicating temporary crack arrest) at the crack tip and their distance is evaluated to be  $23 \pm 9 \mu\text{m}$  in average, although their distance is position dependent.

Fig. 3. Traced fracture surface, providing information about the real fatigue crack surface.
