# Failure analysis of a lead-free brass tap used in potable water

Gan Chunlei\*, Song Dongfu, Zheng Kaihong, Wang Haiyan, Zhou Nan

Guangzhou Research Institute of Non-ferrous Metals, Guangzhou 510650, China

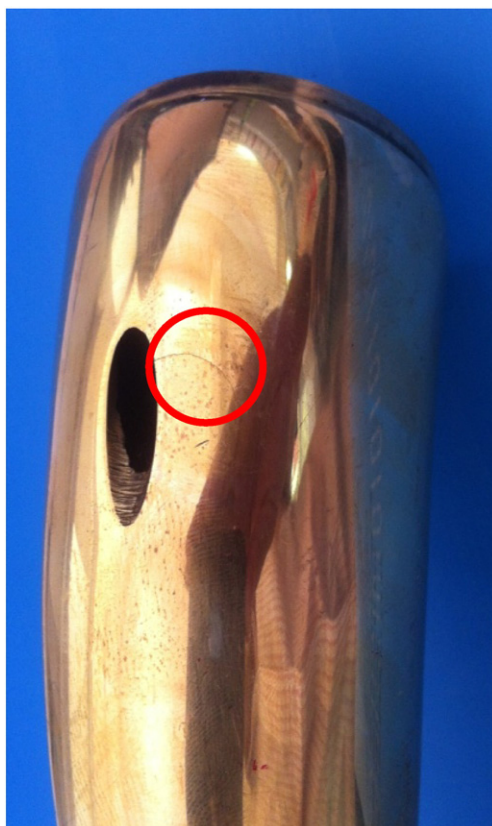
The cracked lead-free brass tap which was received for investigation was photographed using a digital camera. Fig. 1 shows the macroscopic morphology of the representative failed lead-free brass tap. It is clearly seen that the crack location was examined and found in the vicinity of the elliptical plughole zone. The outside surface of the polished lead-free brass tube was smooth. However, the severely curved crack was found to start from the elliptical plughole with about 1.5 mm wall thickness and propagated further toward the depth.

Fig. 1. The macroscopic morphology of a localized crack failure on the surface of the investigated lead-free brass tap (red circle shows the crack zone).
