Microstructural change and impact toughness property of Inconel 738LC after 12years of service

A.S. Golezani ^{*}, M. Bageri, R. Samadi

In this study, the microstructure and impact toughness property of Inconel 738LC have been investigated on V94.2 Siemens gas turbine blade; here we present microstructural change and characterization result of a nickel base superalloys blade under their service after 12 years (105,120 h).

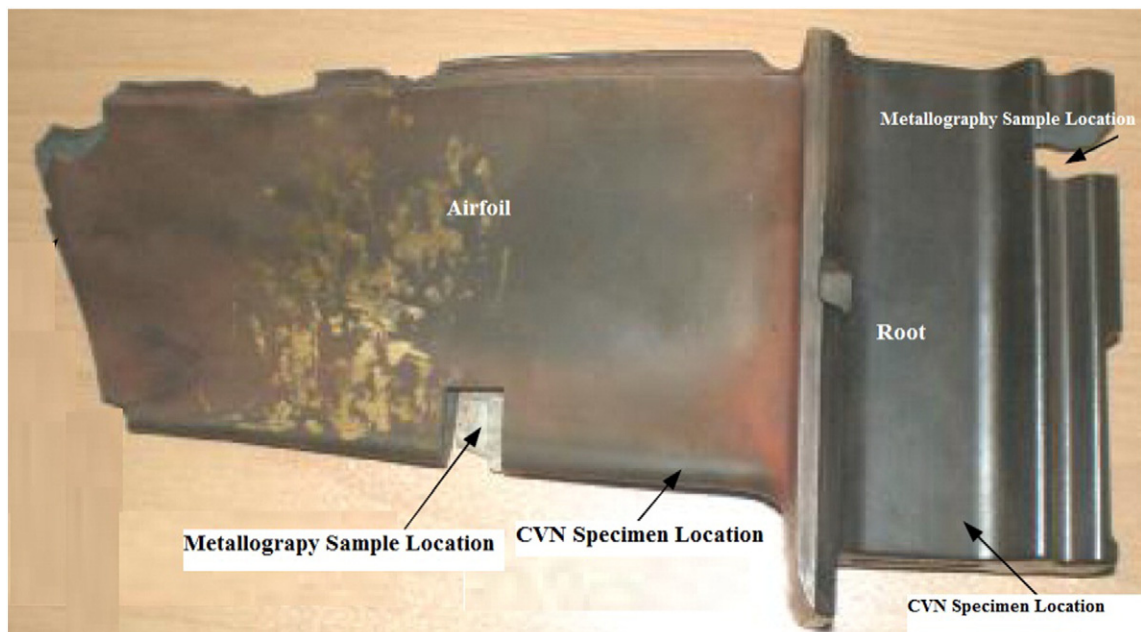
The blade used in this investigation was Inconel 738LC of V94.2 Siemens gas turbine blade with service time 105,120 h and the composition (wt.%): Ni-17 Cr-8.7Co-1.9Mo-3.4 W-0.86Nb-3.2Ti-3.3Al-0.08C-0.04Zr-1.8Ta. Inconel 738LC is a nickel-based superalloy of a different class and mainly used in the hottest part of the turbine. The turbine blade consists of two parts: the airfoil which is exposed to the flow of heat gases, and the root section which attaches the blade to the turbine disk. The airfoil of the blade in the third turbine stage is exposed to hot gases which leads to heating the material to a temperature of up to 850 °C beside the temperature of the blade root which is in the range between 400–600 °C [1–2]. The investigations were carried out in both airfoil and root section. Metallographic samples and Charpy V Notch (CVN) specimens were prepared from airfoil and root. The different locations of the sample in blade are depicted in Fig. 1.

Fig. 1. Inconel 738LC of V94.2 Siemens gas turbine blade with service time 105,120 h.
