Failure of alloy steel socket-head cap screws used in offshore oil production

Low alloy quenched and tempered steels are widely used as screws and studs. In this work screws of AISI 4140 steel were used to bolt the Christma's tree to his cap in offshore oil and gas production. In the moment of the cap re-motion to perform a routine maintenance five 1" screws failed. The screws worked under cathodic protection, which means that they must have undergone hydrogen pick-up. The investigation showed that the screws had been correctly heat treated by quenching and high temperature tempering, but the sulfur content and the level of inclusions were too high. As a consequence, the screws were highly susceptible to hydrogen induced cracking (HIC). On the other hand, the analysis of the fracture surface revealed that the main cracking mechanism was fatigue. The main recommendation resulted from this work is that the specification for new screws for this kind of service must be more restrictive to sulfur and inclusions contents.

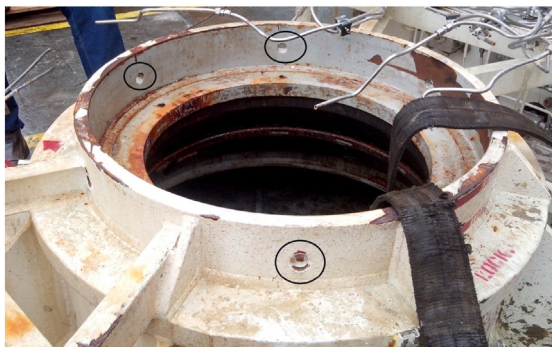
Fig. 2 shows the tree cap after re-motion with the location of the screws failed indicated by circles.

Fig. 2. Tree cap after re-motion – the location of three screws is indicated by circles.
