Resonance of torsional vibrations of centrifugal pump shafts due to cavitation erosion of pump impellers

Adam Adamkowski, Adam Henke, Mariusz Lewandowski *

The Szwedzki Institute of Fluid-Flow Machinery of the Polish Academy of Sciences, Department of Hydropower, Poland

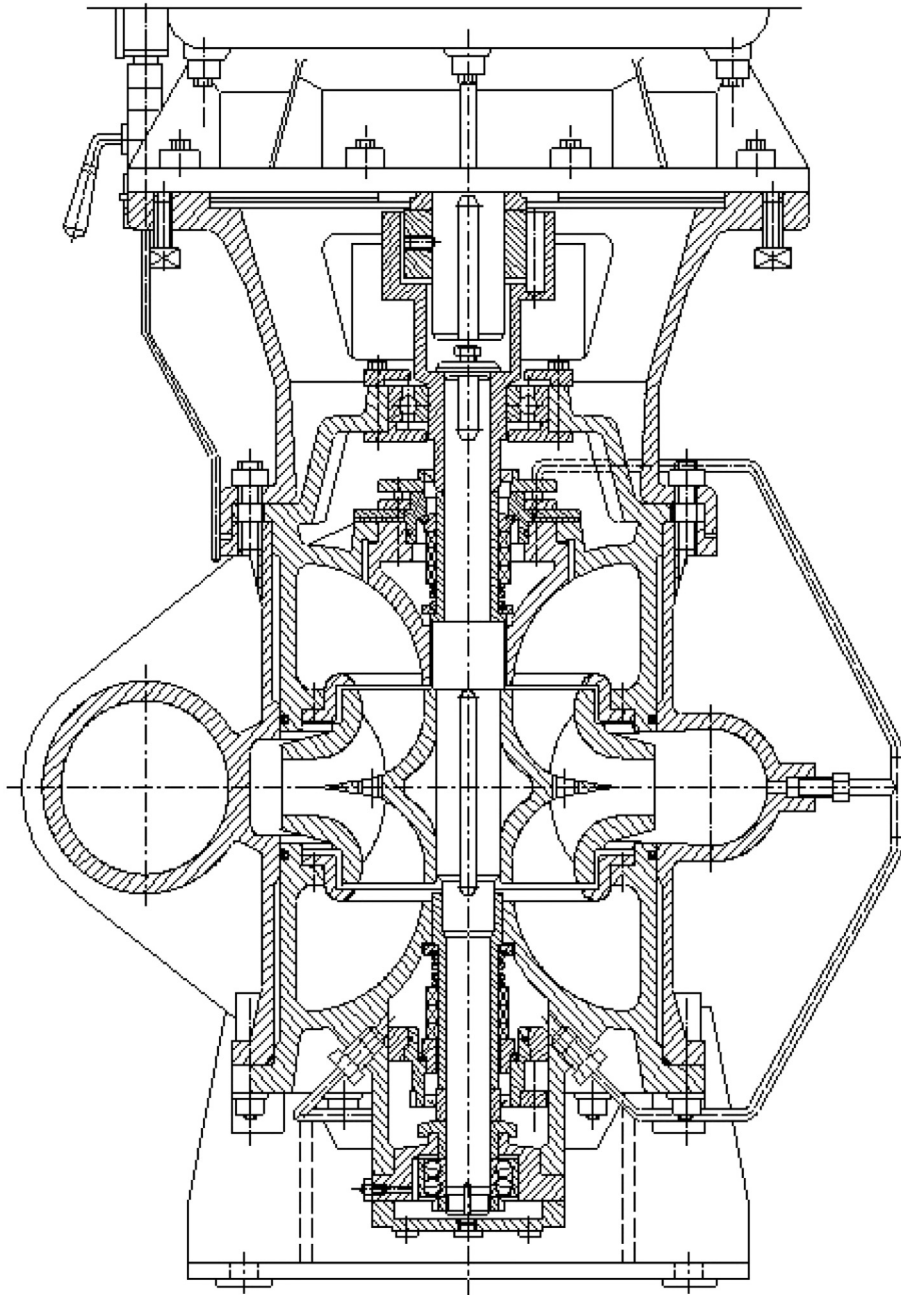
Fig. 1. Axial section of the tested pump.

Three identical, single stage centrifugal pumps with double suction pipes were installed vertically in the seawater cooling system of the power plant equipped with two Diesel generator sets - see Figs. 1 and 2. Each pump had similar bronze impeller with five blades ($i = 5$) and the shaft made of stainless steel. The pumps were driven by the electric motors with the rated power of $P_n = 80$ kW and the rotational speed of $n_n = 1475$ min⁻¹.
