# Structural overloading evaluation based on the identification of subcritical crack increments

Jakub Sedek<sup>a,\*</sup>, Jiri Behal<sup>a</sup>, Jan Siegl<sup>b</sup>

<sup>a</sup> VZLU - Aerospace Research and Test Establishment, Strength of Structures Dpt., Beranovych 130, Prague, Letnany 199 05, Czech Republic

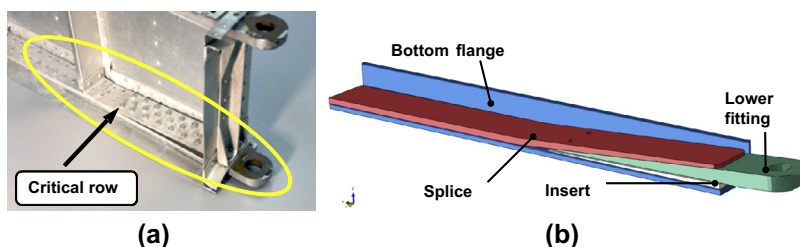
The fracture occurred approximately 200 mm from the wing root through fastener holes in the wings main spar lower flange located in the area of the hinge (see Fig. 1). Fastener holes are drilled perpendicular to the flange base short transverse direction and are countersunk.

Fig. 1. (a) Root spar assembly view and (b) Lower root flange assembly – 3D model.
