# Analysis of surface defects of aluminium components with hard anodized layers

Final quality inspection regularly reveals surface defects on components after hard anodizing. The aim of the analysis was to identify the cause of the defects and unambiguously determine whether the defect is caused by the quality of the base material, manufacturing technology of the component, the heat treatment or by the final surface treatment technology (anodizing). Analysis of the chemical composition and hardness measurements were performed to eliminate the possibility of any errors during material selection and heat treatment process. The capillary test revealed two major defects and also small amount of minor defects. To determine cause of the defects, light and scanning electron microscopy including EDS chemical microanalysis was used. Detailed study of the major defect and EDS microanalysis of its interior confirmed existence of defect prior to coating formation. Further examination of the major defect and its surroundings led to conclusion, that the defect was formed during primary foundry processes when billet was manufactured.

A company involved in the manufacture of air systems approach

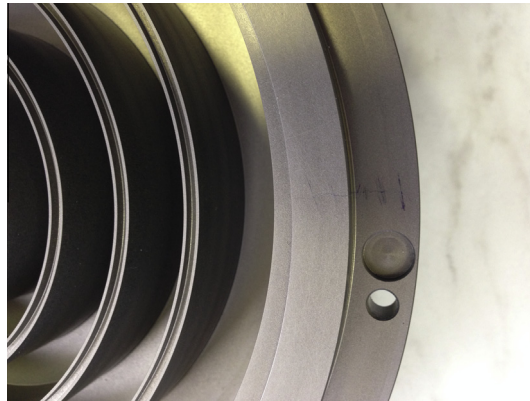
Fig. 1. Component of “STATOR SCROLL”.

Part of the submitted component is shown in Fig. 1, inclusive of the defect identified by the customer.
