Engineering Failure Analysis

Disaster of an industrial hall caused by an explosion of wood dust and fire

Janusz Krentowski*

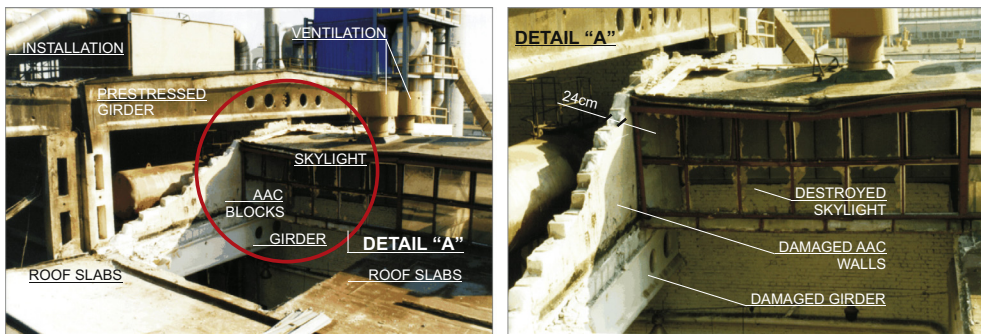
An overview of the halls' constructional damage is shown in Fig. 1.

Fig. 1. Overview of the collapsed hall's construction.
