# Application of material analysis and eddy current conductivity tests to aircraft accident investigation

Lucie Nováková\*, Marie Boháčová, Petr Homola

Strength of Structures Department, Aerospace Research and Test Establishment (VZLU), Beranových 130, 199 05 Prague, Czech Republic

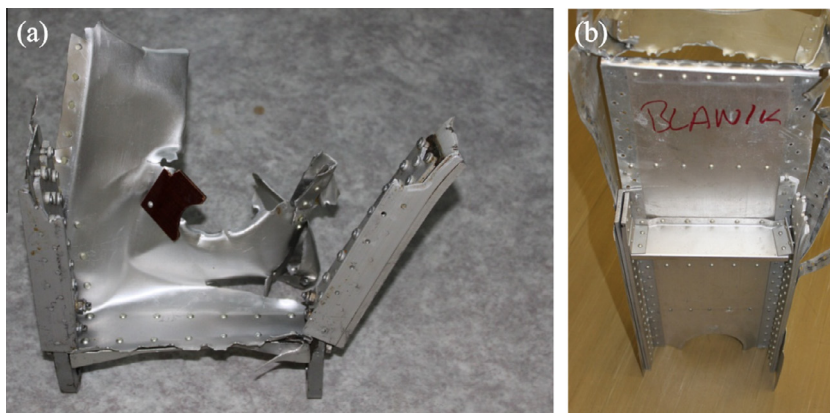
The L13 glider was involved in a fatal accident in Austria on 12 June 2010 when a wing spar failed during flight, resulting in separation of the wing and loss of control of the aircraft [1]. Photographs of the failed flange are shown in Fig. 1.

The failure of the bottom flange of the L13 glider's right wing spar was found during the accident investigation. The detailed fractographic analysis mentioned in [3] confirmed that fatigue failure (the fracture surface is shown in Fig. 2) occurred. Hence, a preliminary assumption was that the fatal accident was caused by premature fatigue failure of the bottom flange of the right wing spar.

Fig. 1. (a and b) Photographs of the failed flange.
