## Failure analysis of induction hardened injector body

M. Horynová\*, M. Juliš, L. Čelko, J. Švejcar

Brno University of Technology, CEITEC – Central European Institute of Technology, Brno, Czech Republic

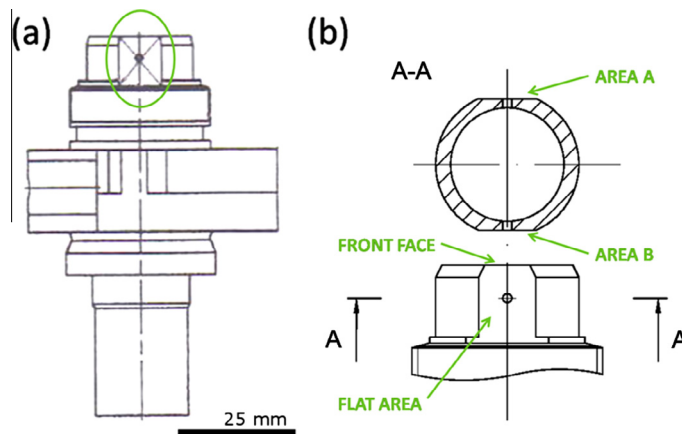
**Fig. 1.** Drawing of injector body: (a) whole component, and (b) detailed drawing of the region of interest.

Two identical injector bodies (marked I and II) were investigated to determine the origin of cracks reported by the producer. The component is shown in Fig. 1a and region of interest, flat area with hole, is highlighted. Detailed drawing of this region is shown in Fig. 1b. As can be seen from the drawing, there are two regions of interest with possible surface defects on

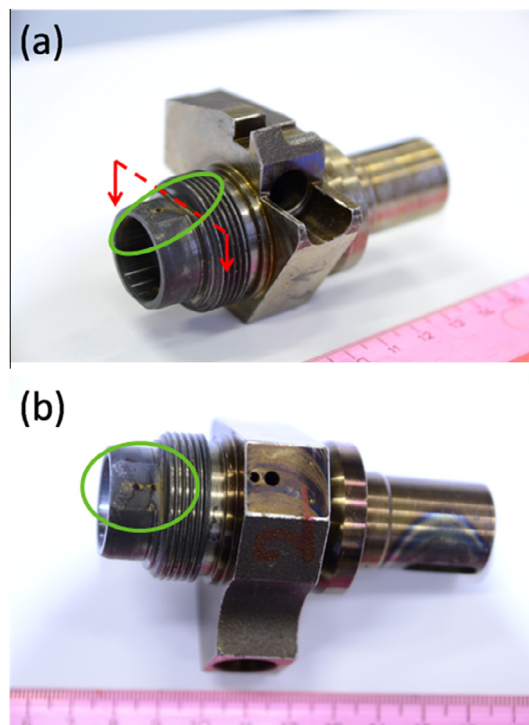
**Fig. 2.** Component I with indication of holes at the flat areas: (a) flat area A with indication of sectioning for metallographic analysis, and (b) flat area B.

The producer reported surface defects, detected by nondestructive testing methods, at the front face of components and at the flat areas with holes.
