# Steam turbine rotor discs failure evaluation and repair process implementation

Zdzislaw Mazur\*, Alejandro Hernandez-Rossette

Instituto de Investigaciones Electricas, Reforma 113, Palmira, 62490 Cuernavaca, Morelos, Mexico

Two rotor discs failed in a 84-MW unit installed in a power plant. The failure was evidenced by large circumferential fractures of blades attachments in both discs. Disc failure was evaluated by investigating rotor operation history, steady state stress analysis by finite element (FEA), disc fracture surface fractography and deposit evaluation. It was found that this disc failure was driven by stress corrosion due to significant static stresses, humid ambient operation and disc material susceptibility. To correct disc failure and restore turbine original characteristics, a disc welding repair procedure was developed. This repair process was implemented and rotor discs restored by weld deposition, post weld heat treatment and machining. As a result, the rotor was returned to service and its useful life extended.

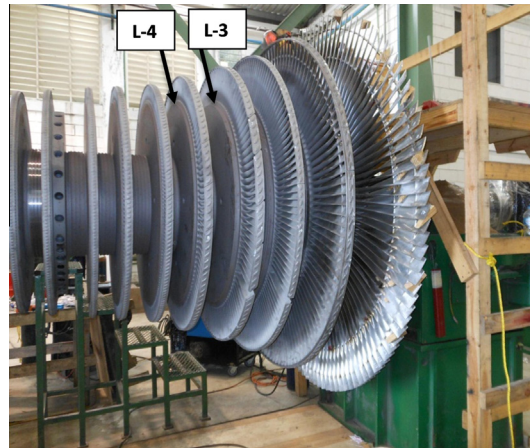
The rotor under evaluation corresponds to an 84-MW, 3600 rpm steam turbine. This unit has a flow high/intermediate/low-pressure turbine composed of 13 stages of blades. This turbine had accumulated 332,000 operation hours (40 years) to failure. A turbine rotor general view is shown in Fig. 1. The failures occurred in stages L-3 and L-4 which are grouped in 6 and 5 blades, as indicated by arrows. Fig. 2 shows axial cracks in the L-3 and L-4 stage disc blade grooves, and Fig. 3 shows circumferential cracks in these same grooves. The circumferential cracks extend to approximately 350 mm in both stages.

Fig. 1. General view of the rotor of the 84 MW steam turbine; the arrows indicate failed discs.

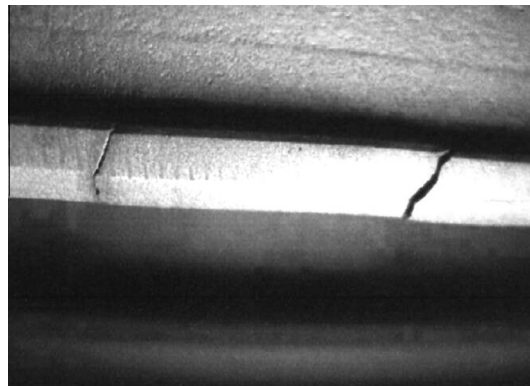
Fig. 2. Axial cracks in the blade grooves.

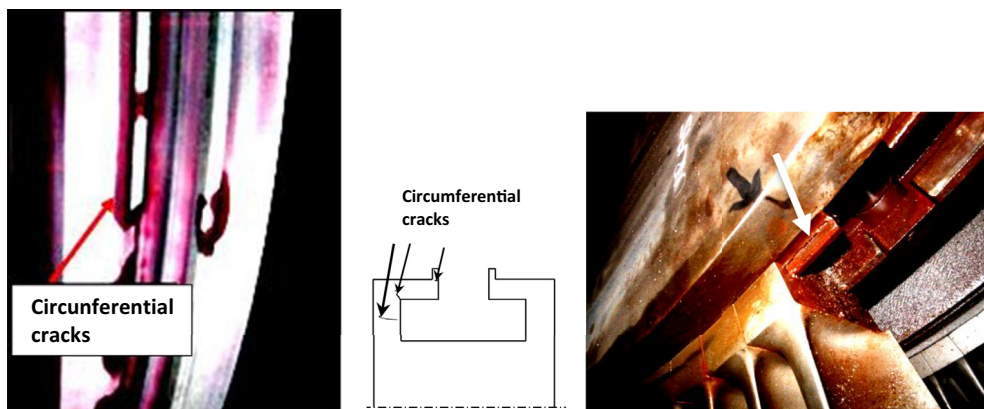
Fig. 3. Circumferential cracks in the blade grooves.
