## Understanding the “blue spot”

# Sodium chloride hot salt stress-corrosion cracking in titanium-6246 during fatigue testing at low pressure

<sup>a</sup> Rolls-Royce plc., Materials — Failure Investigation, Bristol BS34 7QE, UK

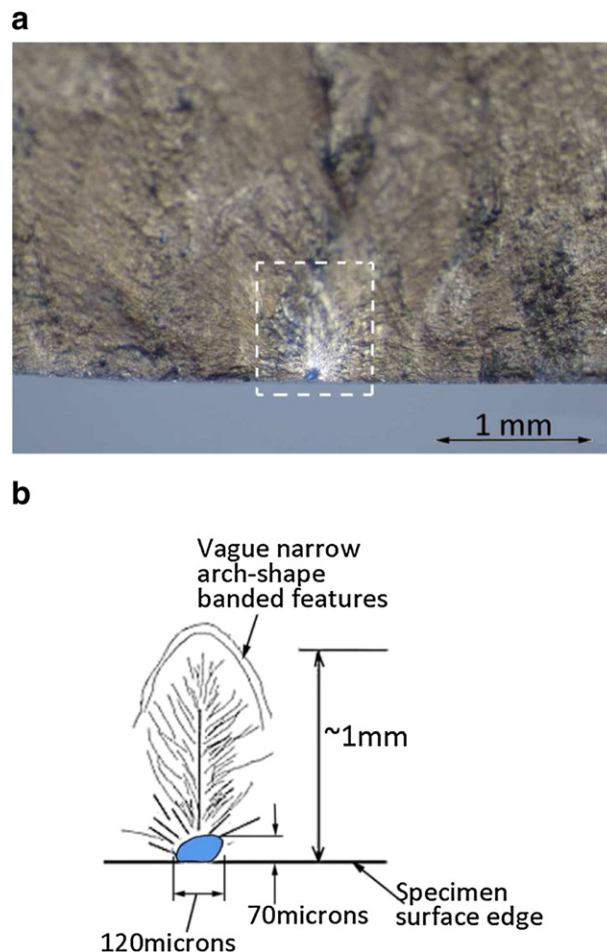
Initial macroscopic fractographic examination at Rolls-Royce revealed tiny optically blue-coloured elliptical features of ~0.1 mm dimension present at the origin of both component crack systems. These have come to be known as the “blue spot” (sometimes “blue/grey”) [11]; Fig. 1.

The “blue spots” were bounded by an abrupt colour change that is unconventional compared to normal ‘growth-out’ temper-colouration on hot cyclic fatigue fracture surfaces [12,13].

**Fig. 1.** (a) A ‘blue spot’ may be seen in this optical image of the ST1 crack origin on the fracture surface, located where an aligned alpha lath colony met the surface shown by the fern-shaped region of growth. Such microstructural features are not uncommon in this material (others may be seen in the image, without ‘blue spots’). (b) Schematic of the area highlighted in (a). “Blue spots” in other specimens (including ST2) were not located at aligned alpha lath colonies or other particular microstructural feature.
