# Failure analysis of an EDM machined mold-printing die used for the production of truck spare parts

S. Leptidis<sup>a</sup>, D.G. Papageorgiou<sup>a,b</sup>, C. Medrea<sup>a,\*</sup>, I. Chicinaș<sup>c</sup>

A company produces truck wheel covers as spare parts for the local market. The production of these parts is based on a progressive die performing consecutive forming and selective cutting stages throughout the initial circular steel sheet. The failure occurred to the final stage of manufacturing, as the die marks, by mold-printing, the assembly configuration of the wheel cover onto the wheel rim. The paper presents a thorough failure analysis of the broken tool. The investigation includes preliminary examination, hardness measurements and chemical analysis. In depth microscopic examination was carried out using stereoscope and optical and electron microscopy. The failure mechanism was investigated from macroscopic and microscopic perspective and conclusions regarding the crack initiation and propagation were conducted and analyzed. The causes that led to the total fracture were discussed. The design of the tool and improper surface roughness are considered to be the main cau

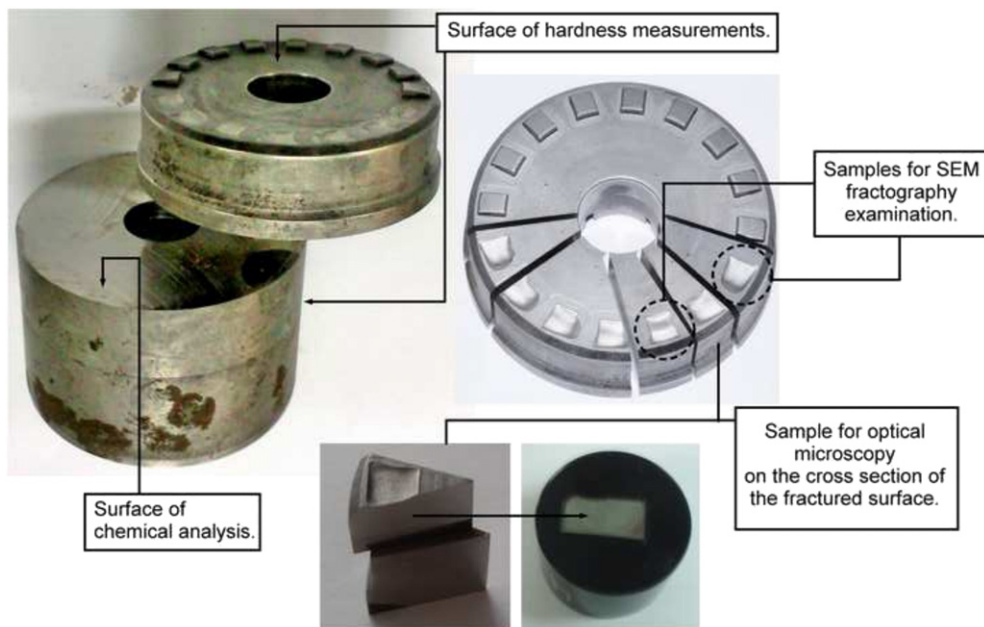
Fig. 1. Fragmentation of the failed die and samples' selection.
