Flow enhanced corrosion of water injection pipelines

Mohamed Hanafy El-Sayed

Central Metallurgical R&D Institute, P.O.B 87 Helwan, Egypt

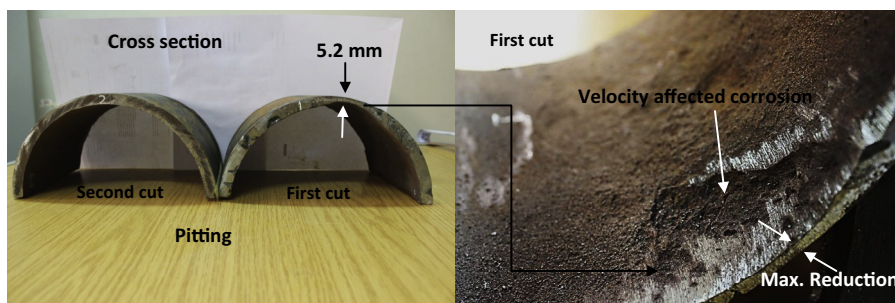
The two cuts contain no signs for weld lines but it was reported that the weld line was at the 10 O'clock position. Fig. 1 shows optical overview for the as-received cuts where black varnish coating exists over the external surface of the second cut and traces remained of the varnish still existed on the outer surface of the first cut.

The external surfaces contain no foreign materials and are not damaged either mechanically or chemically. The internal surfaces have no coating or foreign materials except for corrosion products with more aggressive attack in the first cut. Corrosion is more severe in certain areas of the two cuts in the form of grooves, recesses, scales, and pitting. Thinning took place from the inner surface and the maximum reduction in thickness inside the grooved portion of the first cut is (53%) higher than that of the second cut. Fig. 2 shows stereographic views for the internal surfaces of the two cuts. The inner surface contains shallow recesses filled with brown oxides. These recesses are surrounded by loose adhered scales. This observation suggests the combined action of both corrosive environment and aggressive flow.

Fig. 1. General views for the as-received pipe cuts.
