Failure analysis and retrofitting of superheater tubes in utility boiler

The extreme spray water mass flow rate deviation was observed to occur in the middle temperature superheater of Sahand 2 × 325 MW Power Plant utility boiler, which severely affected its economic performance and safe operation. Boilers operating in these conditions led to failure in superheater tubes at the same place for two consecutive times in a three year span. Thus, the failure analysis of superheater tubes by investigating the visual inspection, chemical, scale and creep analysis was carried out. The brittle failure occurred in the superheater tubes after the fuel was changed from natural gas to heavy oil. Failure analysis showed that tubes were suffering from long term overheating which was instigated by high spray water flow rate. In order to rectify the boiler operating conditions, some modifications were applied in the boiler unit 1 and operating parameters on this boiler were compared with boiler unit 2. The results showed that the 8.33% reduction in heating surface area corresponds to 52.84 and 17.80% reduction in spray water mass flow rate for capacities equal to 300 and 260 MW, respectively.

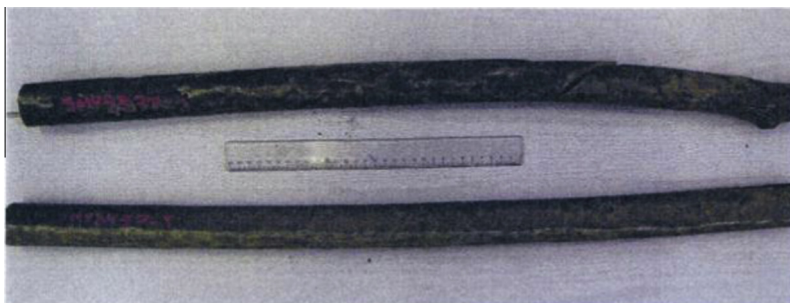
Visual observation of the failed tubes shows that the tubes are bent at several parts (Fig. 2). The outer surface is covered by relatively thick sediment and brittle failure in the different parts of the tube can be observed (Fig. 3). In the case of brittle failures, the micro cracks propagate in the materials and the atoms are gradually separated by tearing along the fracture plane in a very fast way. The path the crack follows depends on the material's structure and the transgranular and intergranular cleavage are important. In this case, it seems that the changing the fuel from gas to heavy oil is provided a crack propagation conditions.

Fig. 2. The image of failed tube.
