Long term effectiveness of life extension methodologies applied to offshore structures

This paper documents developments in fatigue cracking of a floating platform that required repair and upgrading during 1999–2000. The Veslefrikk B (VFB) platform was built in 1985 for drilling exploration but was converted to a production platform in 1989. Shortly thereafter extensive fatigue cracking was discovered and several repairs were made. However, extensive fatigue cracking continued and a retrofit program was implemented, using various types of grinding and peening techniques. In 1999 the platform was temporarily decommissioned and dry-docked for a comprehensive repair and upgrading program, following the International Institute of Welding (IIW) guidelines for weld improvement methods [1], this was completed in only four months. However, after a few more years of service fatigue damage again necessitated new repairs. The majority of cracks occurred in the hull skin plates and caused water leakage. It is noteworthy that cracking this time occurred only in areas of the structure that were left untreated in the first retrofit program due to low levels of stress from FE analyses in these ar

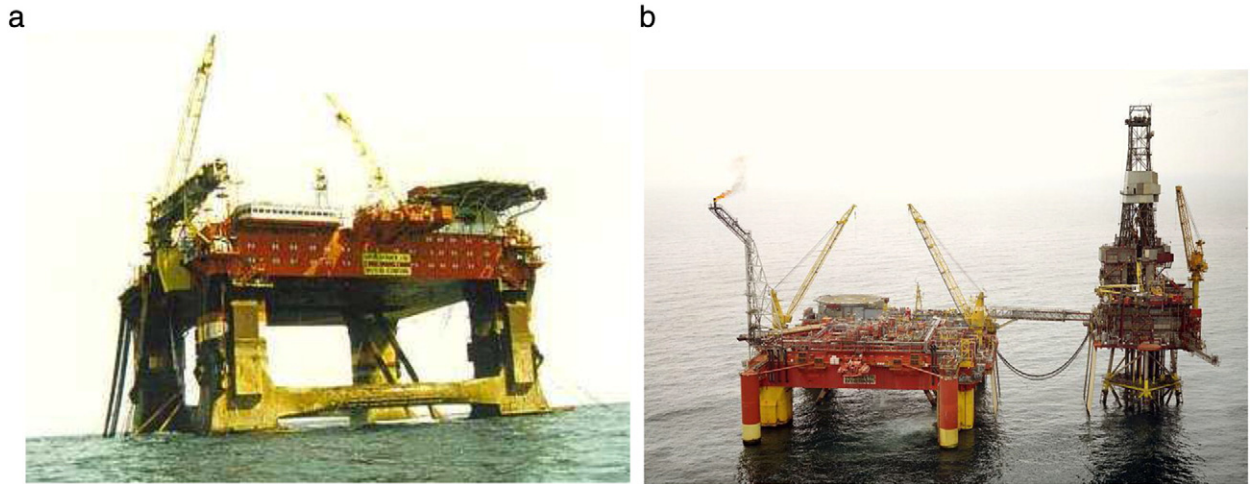
Fig. 1. The Veslefrikk B platform; a) at sea in position for maintenance work; b) after repair and upgrading, moored in place near the Veslefrikk A platform. Note extra columns added to VFB A for stability.

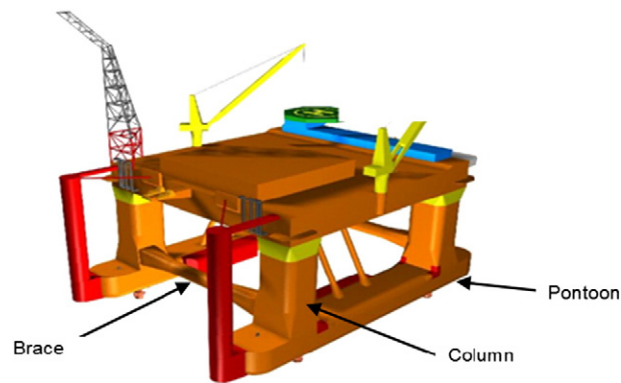
Fig. 2. Structural modifications to the Veslefrikk B platform.

To carry the higher loads in the structure cast steel inserts were introduced in the areas of highest stress in the corners of the pontoons and columns. The size and shape of the inserts were determined on the basis of finite element analyses (FEA), an example of a stress plot is shown in Fig. 4. One of the larger inserts is shown in Fig. 5. The more refined analyses also indicated higher stress levels than initially assumed in the braces and intersections between brace and column.

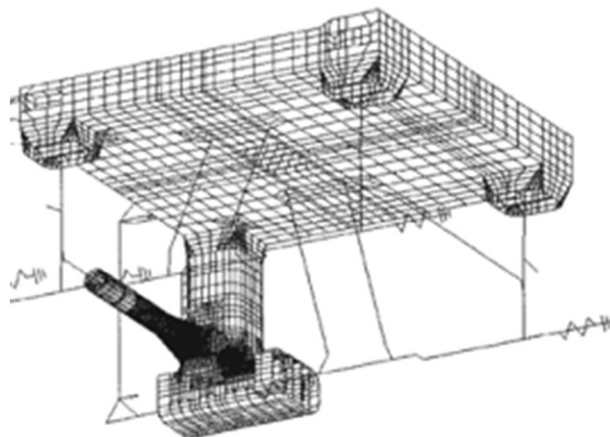
The highest loads occur at the corners where the columns are connected to the pontoons, and the first incidents of cracking were discovered in the pontoon deck plates near the columns. Later cracking took place in various locations near the columns. In preparation for the upgrading and strengthening of Veslefrikk B extensive stress analyses were performed using finite element methods (FEM) to identify areas of high local stress. New buoyancy elements had to be added to compensate for the increased weights caused by the extra weight of supplementary production and processing equipment, the new structural configuration is shown in Fig. 2. Areas that were subjected to severe cracking are indicated in Fig. 3. FEA plots are shown in Figs. 3 and 4, indicating highly stressed areas.

Fig. 3. Finite element analysis plot of part of the platform, indicating high stresses in brace to column and pontoon region.
