## Failure analysis of stress corrosion cracking in heat exchanger tubes during start-up operation

Shugen Xu<sup>a,\*</sup>, Chong Wang<sup>a</sup>, Weiqiang Wang<sup>b</sup>

In 2014, a tube-shell heat exchanger E101/E102 for dimethyl ether to propylene project failed due to the leak of tubes during the first start-up operation. The specification of the heat exchanger E101/E102 is listed in Table 1. E101 and E102

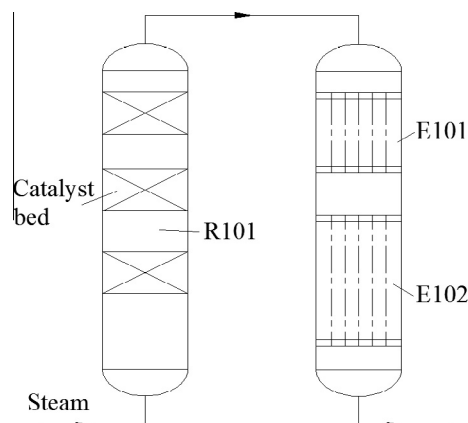
are assembled in one vessel with the serial tube side, as shown in Fig. 1. In the normal production process, the feed fluid of reactor R101, water and dimethyl ether are heated in shell side of E101. The water and methanol are heated in shell side of E102. The products of R101, water and propylene are cooled down in tube side of E101 and E102. In the first start-up operation, R101 and E101/E102 are heated by the high temperature steam from the boiler, as shown in Fig. 1.

E101/E102 was fabricated in May 1, 2014, and tried to start-up in June 21, 2014. The pre-heating steam flows through R101 to heat the catalyst bed, and then pre-heats E101/E102 through tube side. The temperature increased from 30 °C to 320 °C during 4 days and kept constant in the later 4 days. The leakage of E101/E102 was found in June 28, 2014. The tube cracks were located in the end of seal expansion section, Zone-I and Zone-II, as shown in Fig. 2. The inner surface of failed tubes was corroded, on which some reddish brown corrosion products were observed. Some circumferential cracks in inner and outer surfaces of tube can be found. Fig. 3 shows the appearance of cracks in Zone-I of Tube-A. No obvious plastic deformation can be found around the fracture zone. Fig. 4 shows the appearance of cracks in Zone-II of Tube-B. The cracks originated in inner surface and propagated to the outer surface, as shown in Fig. 3(b).

Fig. 1. The pre-heating steam flow during start-up operation.
