Short communication

Failure analysis of heat exchanger tubes of four gas coolers

S.R. Allahkaram^{a,*}, P. Zakersafae^b, S.A.M. Haghgoo^b^a Center of Excellence in High Performance Ultra Fine Materials, School of Metallurgy and Materials Engineering, University College of Engineering, University of Tehran, P.O. Box 11155-4563, Tehran, Iran^b School of Metallurgy and Materials Engineering, University College of Engineering, University of Tehran, P.O. Box 11155-4563, Tehran, Iran

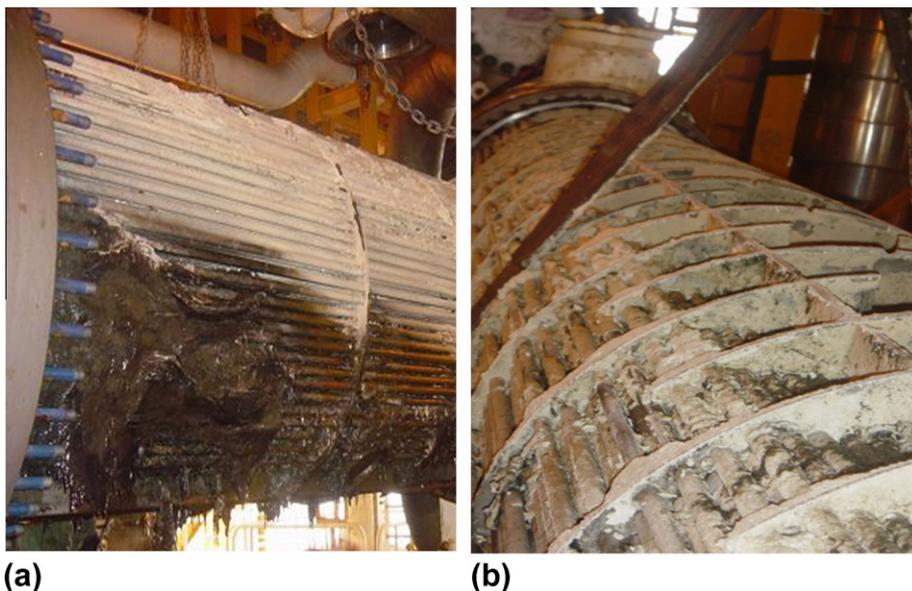
During one of the overhauls, tubes were removed for inspection. Fig. 1 shows inside the gas cooler after the shell has been removed. It can be seen that they fouled by marine growth and corrosion deposits.

Fig. 1. (a) Fouling by marine growth on heat exchanger external tubes and (b) formation of deposit on tubes.
