# Numerical stress and crack initiation analysis of the compressor blades after foreign object damage subjected to high-cycle fatigue

Lucjan Witek

This paper presents results of the complex stress and crack initiation analysis of the PZL-10 W turbo-engine compressor blade subjected to high cycle fatigue (HCF). A nonlinear finite element method was utilized to determine the stress state of the blade during the first mode of transverse vibration. In this analysis, the numerical models without defects and also with V-notches were defined. The quality of the numerical solution was checked by the convergence analysis. Obtained results were next used as an input data into crack initiation ( $\epsilon$ - $N$ ) analyzes performed for the load time history equivalent to one cycle of the transverse vibration. In the fatigue analysis the different methods such as: Neuber elastic-plastic strain correction, linear damage summation and Palmgreen-Miner rule were utilized. As a result of  $\epsilon$ - $N$  analysis, the number of load cycles to the first fatigue crack appearing in the compressor blades was obtained. Moreover, the influence of the blade vibration amplitude on the number of cycles

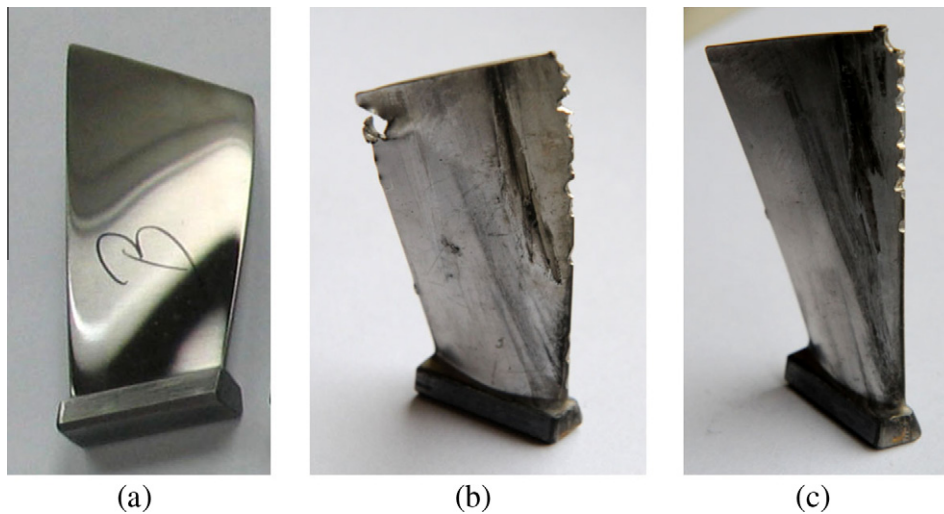
**Fig. 1.** View of the 1st stage compressor blade used in PZL-10 W turbo-engine (a), and blades after foreign object damage (b and c).

The compressor blade (Fig. 1a) is susceptible to foreign object damage (FOD). The ingestion of foreign objects into aircraft jet engines can lead to severe structural damage of the fan or compressor airfoils. The high airflow required to operate such engines creates a powerful suction effect which tends to draw in small objects from area around the aircraft.

Damage of the compressor blades of engine is normally caused when a particle is hit by the rotating blade. There is high relative velocity due to the motion of the blade and acceleration of the particle causes high forces and local damage to the blade. Often this damage is at or close to the attack (leading) edge of the compressor blade and takes the form of a dent or notch in the leading edge (Fig. 1b and c). Foreign object damage is a prime reason for maintenance and reparation of military jet engines which operate on landing grounds. The damage induced by small hard objects of millimeter size in conjunction with the typical load spectra experienced by airfoils can lead to non-conservative life prediction and unexpected fatigue failures.
