Failure analysis of the super heater tubes of S-combined power plant

By analyzing the measured temperature, fatigue life, and damages due to continuous appearance of crack within the interior of the combined cycle power plant's intermediate temperature (IT) and high temperature (HT) super heater header and finned tube weld, the causes of the damages were identified.

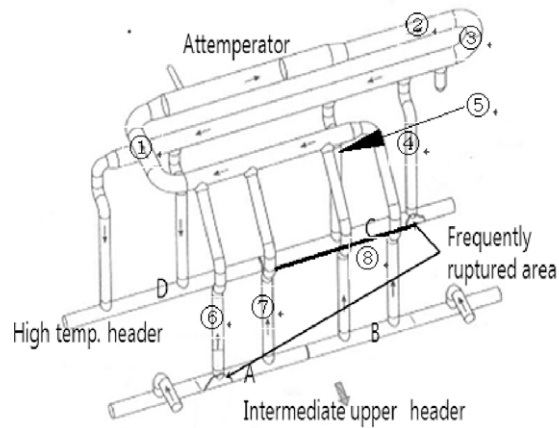
The 'S' combined cycle power plant's HRSG utility is experiencing tube damages at lower part of "A" and "C" as can be seen in Fig. 2. Part "A" experienced 15 counts, and Part "C" counts seven damages. The damage areas are the link area that is near normal attemperator.

Fig. 2. Structure of connecting part of upper IT header and HT header.

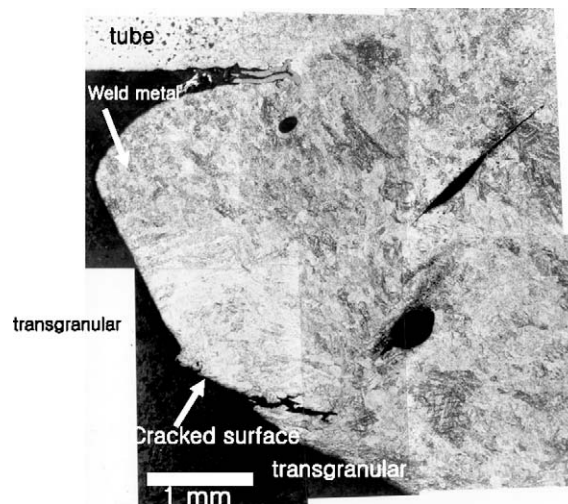
Fig. 3 shows the fractured surface of damaged header and tube weld. In order to analyze the cause of fractured tube's damages, damaged surface was analyzed using SEM. The crack grew penetrating weld metal in 50–70° as can be seen in

Fig. 3. Fracture surface of damaged header and tube weld.
