Failure analysis of connecting bolts and location pins assembled on the plate of main-shaft used in a locomotive turbocharger

Zhiwei Yu *, Xiaolei Xu

College of Electromechanics and Material Engineering, Dalian Maritime University, Dalian 116026, PR China

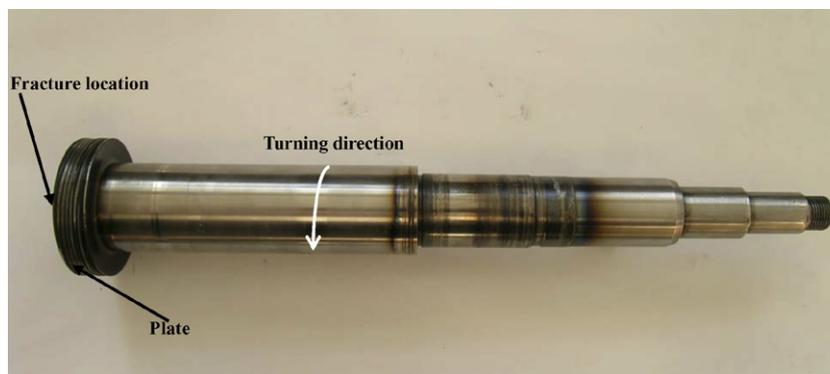
Fig. 1. Main-shaft showing fracture location.

Connecting bolts and location pins connected a turbo-disk with the plate of main-shaft, and the navel of turbo-disk fractured during servicing. The failed main-shaft system was used in a locomotive turbocharger, which had serviced for 1,00,000 km.

The main-shaft showing the fracture location is shown in Fig. 1. The fractured connecting bolts, location pins and navel of turbo-disk were assembled on the plate of the main-shaft end (Fig. 2). The fractured bolts and pins are, respectively, numbered as bolt 1, pin 2, pin 3, bolt 4, bolt 5 and pin 6 in Fig. 2.
