Analysis of turbo impeller rotor failure

Thiago Figueiredo Azevedo^a, Raphael Calazans Cardoso^{a,*}, Paulo Rogério Tavares da Silva^b,
Abraão Santos Silva^a, Sandro Griza^a

The aim of the current study is to analyze the failure of a turbo impeller rotor made of AA 7075 aluminum alloy. We found a drilled hole partially out of position, and it might have been the possible cause of failure. The aim of the analysis is to check the influence of the machining mistake on the failure. Fracture analysis techniques were performed through scanning electron microscopy and low-magnification optical microscopy. The alloy was characterized through chemical, microhardness and microstructural analyses. The numerical simulation was performed to check the stress level generated in the impeller depending on the size of the hole chamfer and on the introduction of the machining mistake. We concluded that the failure in the rotor began in a hole adjacent to the partially drilled one and attributed the fracture onset to the stress concentration caused by the chamfer burrs and by the unbalance caused by the partially drilled hole.

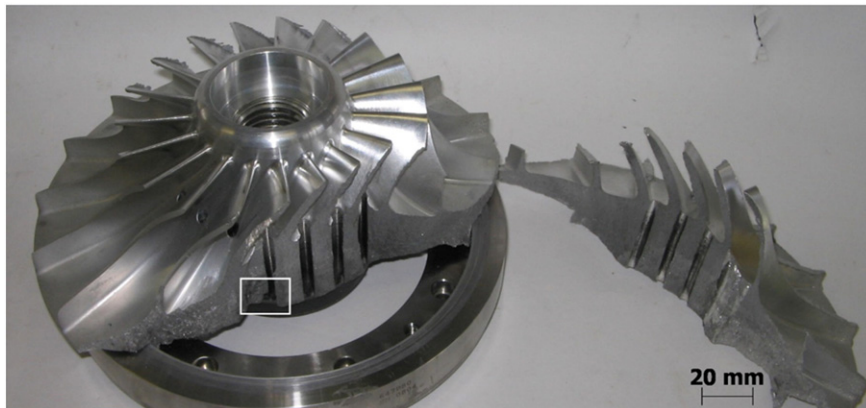
Fig. 1. Turbo impeller rotor fractured during operation. The white rectangle indicates the partially drilled hole.

The machining mistake might have caused a change in the section and it might have been the stress generator or might have caused the unbalance in the rotor, thus favoring the failure onset.

The aluminum turbo impeller rotor with fracture in two parts of the maze ring is shown in Fig. 1. There is no contact between these two parts due to the assembly. However, the failure forced the rotor to fit the internal thread of the maze. The hole out of specification is shown in Fig. 2.

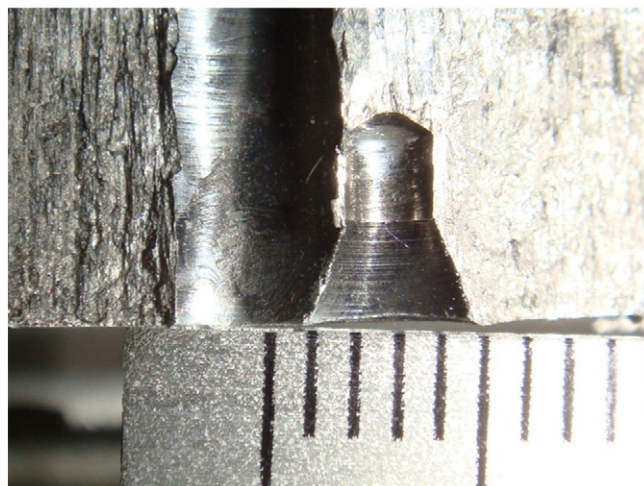
The herein analyzed rotor is a turbo impeller made of AA 7075-T6 aluminum alloy. It weighs 6 kg and its external diameter is 280 mm. The shaft operates at 989 kW, with rotation at 22,918.31 rpm. The input pressure in the impeller is 6423 kPa, at $-25\text{ }^{\circ}\text{C}$; and the discharge pressure is 2170 kPa, at $-69\text{ }^{\circ}\text{C}$. On the other hand, the pressure in the impeller during operation is 4317 kPa, at $-47\text{ }^{\circ}\text{C}$. The rotor has nineteen 5-mm-diameter through-holes disposed around the circumference along the flange base. The manufacturer interrupted the machining of the first hole when he realized that the drilling was being done at the wrong coordinates. Next, he corrected the coordinates and restarted machining. Such correction left a partially drilled hole next to the correct one. Finally, the adjacent holes were drilled.

Fig. 2. Partially drilled hole shown in Fig. 1.
