# Metallurgical investigation into the failure of an iron ore sintering car pallet

A failure analysis on premature cracking of a sintering car pallet in an integrated steel plant is presented. A detailed study on the microstructural and mechanical properties of the failed component has been carried out. Microstructurally, the amount of pearlite in the ferritic–pearlitic matrix was found to be significantly higher (~65.8%) than normally expected in materials used for elevated temperature application. A thin layer of flake and vermicular graphite (degenerate graphite) was found just beneath the casting skin although interior of the matrix contained normal spheroidal graphite. In few occasions, the presence of undesirable spiky and exploded graphites was also noticed. The material exhibited lower yield stress (312 MPa), tensile strength (457 MPa) and Charpy impact energy (3.4 J) indicating poor strength and toughness of the casting. The improper graphite morphologies in the sinter car pallet acted as stress raisers and produced cracks under dynamic thermal cycling and external loads experienced during the sintering process resulting in its premature failure.

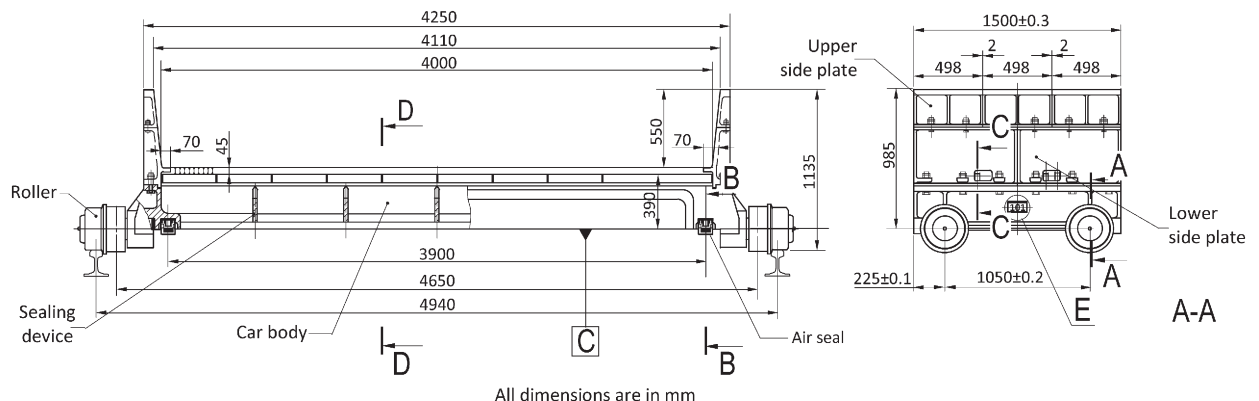
Fig. 1. Engineering drawing of the sinter car pallet.

The present work deals with the metallurgical investigation of a prematurely failed sintering car pallet received from an integrated steel plant. The engineering drawing of the sinter car pallet is shown in Fig. 1. The sinter machine consisted of around 130 numbers of sintering car pallets. The material used in the sinter pallet car conformed to GGG 60 grade cast iron of DIN 1693 standard (presently EN-GJS-600-3 grade in European Standard EN 1563) which is basically a ferritic–pearlitic grade spheroidal graphite (SG) cast iron. One of pallets failed prematurely during operation within 3 months of service, while the expected service life of sinter car pallet is around 20–25 years. The sudden failure of the sinter pallet involved huge cost due to the production loss and replacement of the failed component. Although the fracture of side plates [1] and pallet axle [2] are often noticed in sinter plant operation, but premature failure of pallet car body is not a common phenomena under similar working conditions and has not been reported in literature. Hence, the present work was found unique in nature and a sincere effort was made towards detailed metallurgical investigation encompassing visual inspection, light microscopy, image analysis, mechanical testing and scanning electron microscopy of the cracked sinter car pallet which failed prematurely in service.
