Failure analysis of a natural gas pipeline

Yafan Zhao ^{a,*}, Mingda Song ^b

A L390 natural gas pipeline exploded in 2011 in China. Macrofracture examination, thickness measurement, chemical composition analysis, metallographic inspection, mechanical property testing, fracture scan electronic microscopy examination and environment analysis were conducted to the burst pipeline. The results showed that Stress Corrosion Cracking (SCC) generated in the mechanical damaged zone of the pipeline was the reason of the failure. This kind of cracking was induced by Cl^- and HCO_3^- in near neutral corrosive medium of pH value. The stress concentration was induced by the groove damage under inner pressure.

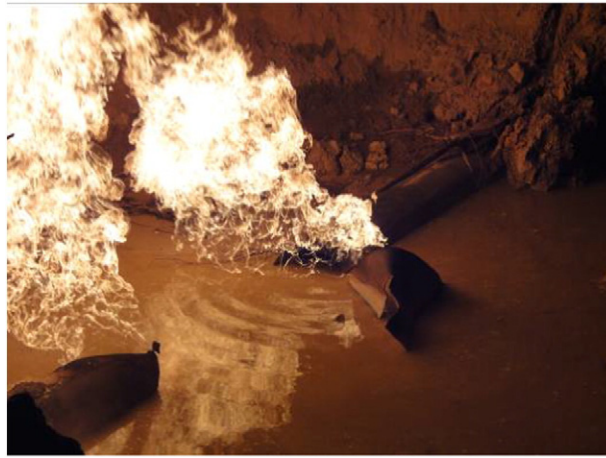
Natural gas pipelines need a high level of reliability and safety. Failure analysis of the fracture cases can provide a warning to the in-service pipeline. Failure cases involving of natural gas pipeline are not rare [1–3]. Both the experiment and simulation approaches were used for the failure reason detections [4–6]. Some life prediction [7] and integrity assessment [8] works were conducted for the pipeline steel to prevent the abnormal failures during service. In this paper, a failure case of a natural pipeline burst was introduced. The accident happened on July 2nd in 2011, which damaged about 100 m² forest and lead to a villager's severe burnt, as shown in Fig. 1.

Fig. 1. Field of fire.

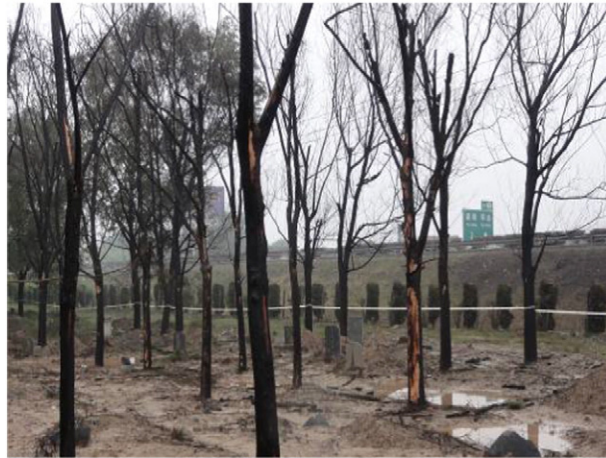
The accident site is located at about 50 m south of Yellow River Second Dam and about 100 m north of Jinan–Qingdao expressway, as shown in Fig. 2. The explosion point of the pipeline was located on the shore of a sewage ditch, as shown in Fig. 3. About 50 m east of accident spot, about 5 m of the casing pipeline was immersed in the sewage ditch, as shown in Fig. 4.

Fig. 2. The fired trees around fracture pipeline.

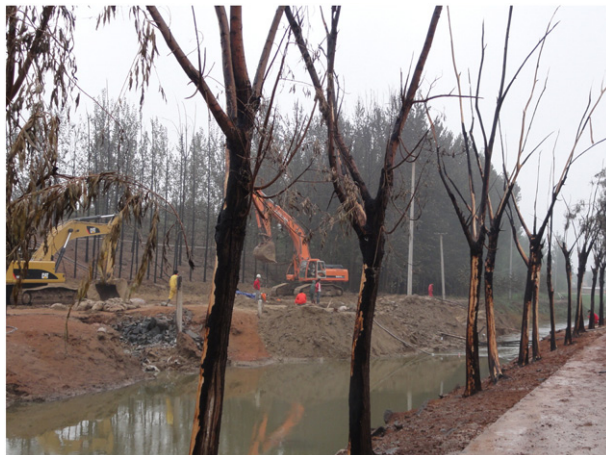
Fig. 3. The sewage ditch in the south side.
