Corrosion failure analysis of pure nickel thermocouple sheath used in BaTiO₃ hydrothermal synthesis reactor

X.Y. Zhong^a, X.Q. Wu^{a,*}, E.H. Han^a, X.B. Song^b

This paper presents corrosion failure analysis on a commercial pure nickel thermocouple sheath used in BaTiO₃ hydrothermal synthesis reactor. Detailed investigations of the corrosion products have been performed using stereomicroscope, X-ray diffraction, scanning electron microscopy and energy-dispersive X-ray spectroscopy. It was found that the corrosion failure of the sheath was mainly due to general corrosion and crevice corrosion of pure nickel, and the main corrosion products were Ni(OH)₂. Many cracks were observed inside the corrosion products and along the interfaces between the corrosion products and metal matrix. BaTiO₃ particles were deposited as parallel white bands along the above cracks inside the corrosion products. Chloride ions also entered the cracks or crevices, resulting in the acidification inside the crevice and aggravated the attack of nickel matrix. Some recommendations to prevent/minimize future similar corrosion failures were proposed.

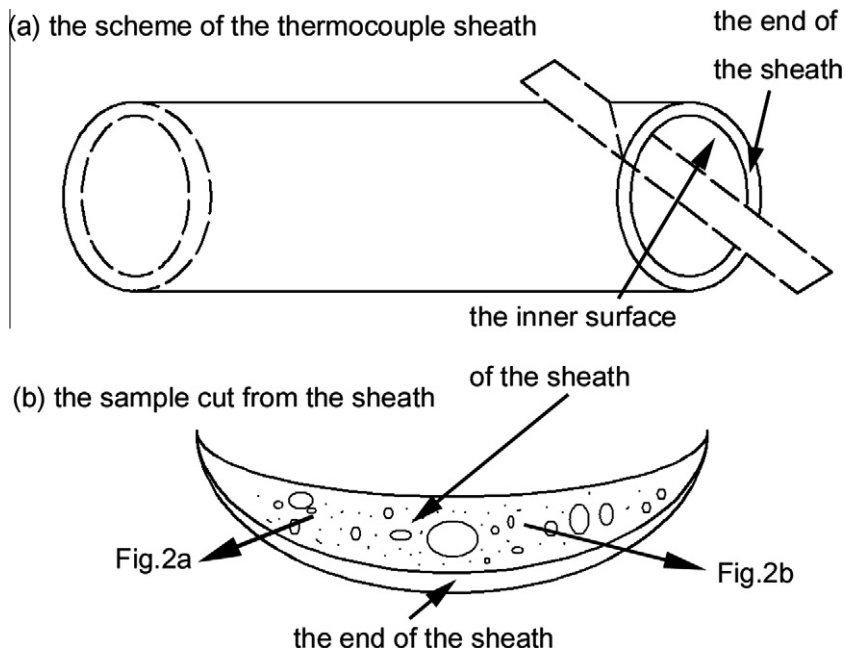
Fig. 1. Scheme illustration of the geometry of the sample: (a) the scheme of the thermocouple sheath, (b) the sample cut from the sheath.
