Root cause failure analysis of a division wall superheater tube of a coal-fired power station

M.M. Rahman ^{a,*}, J. Purbolaksono ^a, J. Ahmad ^b^a Department of Mechanical Engineering, Universiti Tenaga Nasional, Km 7 Jalan Kajang-Puchong, Kajang 43009, Selangor, Malaysia^b Kapar Energy Ventures Sdn Bhd, Jalan Tok Muda, Kapar 42200, Malaysia

This work presents failure investigation on a division wall superheater tube of Boiler Unit 4 at Sultan Salahuddin Abdul Aziz Shah Power Station by visual inspections, metallurgical examination and temperature estimation using the empirical formula. The findings obtained from the investigation are discussed to deduce the failure mechanisms and the root cause of the failure.

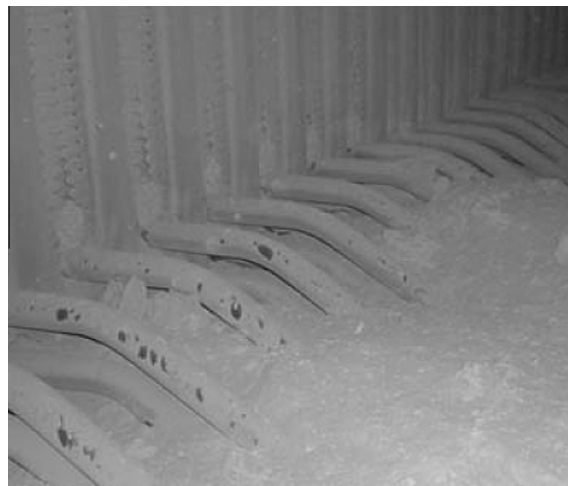
Boiler unit number 4 at Sultan Salahuddin Abdul Aziz Shah Power Station was noticed to have operated normally until firing of Bontang coal. It is a medium standard coal that was imported from East Kalimantan, Indonesia. The coal started to be

Fig. 1. Massive clinkers covering superheater region.
