Fatigue fracture analysis of gas turbine compressor blades

Gas turbine compressor blades are subjected to centrifugal and vibratory loads. This repeated loading and unloading can reduce the life of the compressor blades. An experimental procedure has been done to investigate the fatigue crack propagation in blades. Microstructure and fracture surface of the blade have been investigated by optical and scanning electron microscopy. Fatigue crack propagation considering the effect of corrosive environment has been studied. Environmental and micro-structural features revealed that the catastrophic fracture was initiated from the corrosion pit on the leading edge of the blade.

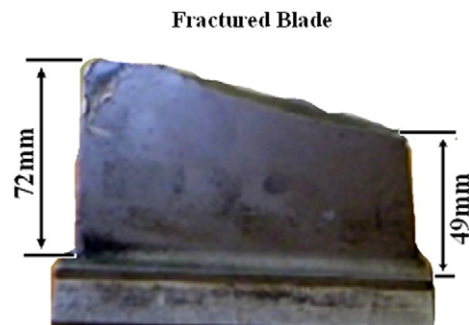
Fig. 1. The fractured blade and the failure location on it.
