### **Engineering Failure Analysis**

# Failure of Alloy 20 nozzles used for spraying sulfuric acid in an incineration furnace

Amnuaysak Chianpairot\*, Piya Khamsuk, Kosit Wongpinkaew, Siam Kaewkumsai, Ekkarut Viyanit

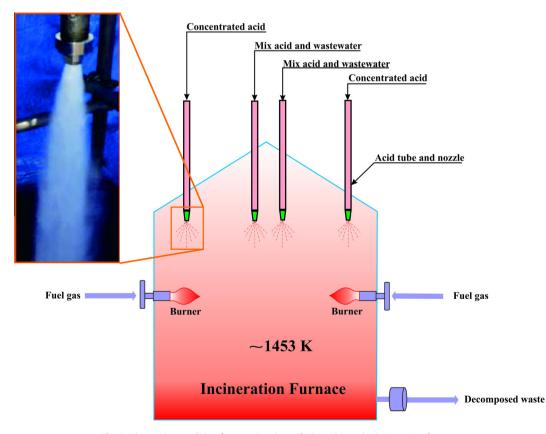
In the current work, a petrochemical plant has experienced premature failure of the nozzles used for feeding concentrated sulfuric acid into an incineration furnace, where process wastes are decomposed through reaction with acid at high temperature. The service condition of nozzle and a schematic drawing of the incineration furnace are shown in Fig. 1. During service, the temperature inside the furnace, which was monitored by an infrared pyrometer, was maintained at about 1453 K. Concentrated sulfuric acid (98.5%) was transported into the incineration furnace through a tube at pressure up to 350 kPa above ambient. The liquid inside the tube and the nozzle was maintained at temperature of 313–323 K and was immediately fed into a mixing chamber inside the nozzle set. In the mixing chamber, the two-phase mixing between liquid sulfuric acid and air at high speed caused atomization of liquid sulfuric acid into droplets [5] with mean size finer than 25 µm, which left the nozzle tip into the incineration furnace.

Fig. 1. The service condition for spraying the sulfuric acid into the incineration furnace.
