Failure of a furnace outlet pipe in a benzene plant by internal oxidation due to improper welding practice

H.M. Tawancy*

Center for Engineering Research, Research Institute, King Fahd University of Petroleum and Minerals, P.O. Box 1639, Dhahran 31261, Saudi Arabia

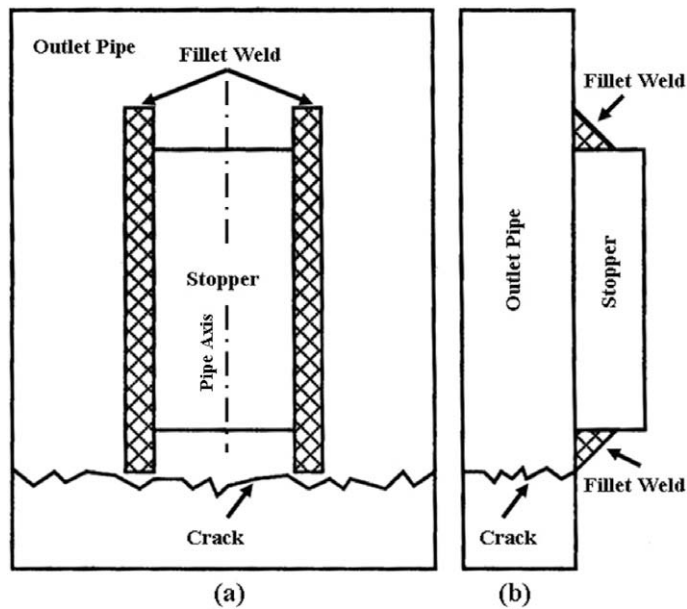
Fig. 1. A schematic illustration of the outlet pipe showing the location of the transverse crack. (a) Surface and (b) Cross-section.

After an unspecified period of operation the outlet pipes developed transverse cracks near the fillet weld as shown in Fig. 1. A section of the failed pipe containing the crack was received for analysis to determine the cause of failure.

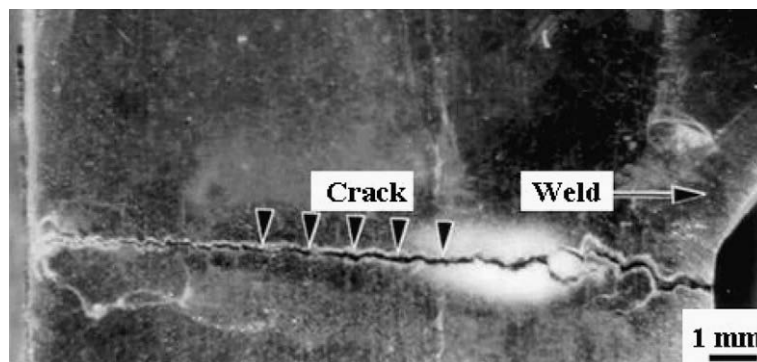
A light optical macrograph showing the general appearance of the transverse crack near the weld is shown in Fig. 2. It is observed that the crack is oriented nearly normal to the pipe axis suggesting that it was not related to the stresses generated by the internal pressure since the respective maximum tensile stress tends to produce longitudinal rupture. Also, the maximum circumferential (hoop) stress (σ_1) estimated on the basis of a thick-walled cylinder ($d_i/t = 7.85 < 10$ where d_i is the

Fig. 2. A macrograph illustrating a transverse crack in the outlet pipe near the weld.
