Analysis of corrosion of hot-rolled X70 steel plate during storage

In this work, analysis was performed to investigate the reason resulting in corrosion, especially pitting corrosion, of a stock of hot-rolled X70 steel plates after 4 months of storage in a warehouse. Results demonstrated that corrosion and pitting corrosion of X70 steel plate during storage is attributed to the remnant and concentration of cooling water on the top surface of the plate. Pitting corrosion occurs locally at defects on surface deposit that is generated during corrosion of the steel. The small anode vs. big cathode geometry enhances the pitting corrosion process. Chloride ions enter the pits to maintain the charge-neutrality, while ferrous ions that are generated during corrosion diffuse out of the pits to result in corrosion product layer at pit mouth.

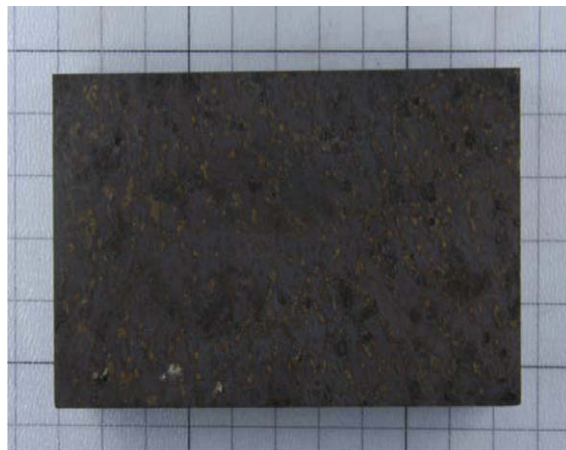
Visual examination of the surface of corroded X70 steel plate showed that a significant number of corrosion pits existed on the up-surface of the plates, as shown in Fig. 2. However, there was no obvious corrosion pits visible on the down-surface (Fig. 3).

Fig. 2. Optical view showing the up-surface with corrosion and corrosion pits.
