Failure analysis of connecting bolts used for anchoring streetlights of a mountain highway

D. Pilone*, A. Brotzu, F. Felli

Dip. ICMA, Sapienza Università di Roma, Via Eudossiana 18, 00184 Roma, Italy

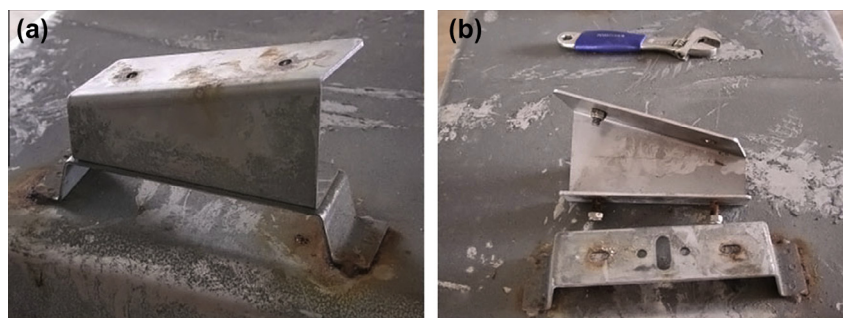
The streetlight placed in service is equipped with angled brackets and presents the failure of the bolts connecting them to the metallic band used for the connection with the cable trunking. Three of the four screws showing clear signs of corrosion are still present on the brackets. The lighting body is entirely covered with a layer of dust that during disassembly of the various components appears infiltrated between the brackets. In the areas close to the welds corrosion products are also visible, while on the casing corrosion pits are sporadically visible.

Fig. 1. Macrographs showing the bridge-shaped bracket fixed to the angled bracket (a) and the corroded bolts (b).
