Effect of coking in massive failure of tubes in an ethylene cracking furnace

Jose Luis Otegui ^{a,*}, Jeremías De Bona ^b, Pablo G. Fazzini ^b

^a YPF Tecnología S.A., Conicet, Argentina

^b GIE S.A. Integrity of Assets, Argentina

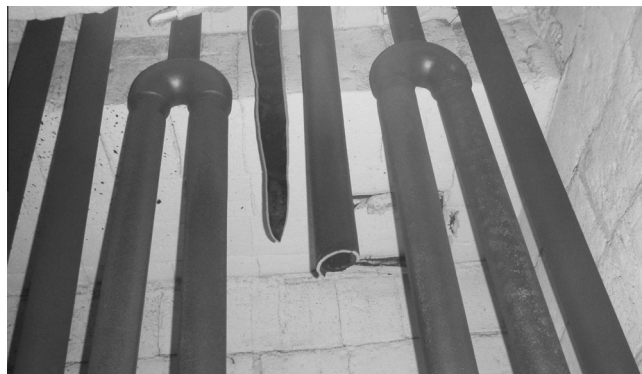
During an emergency stop the furnace was taken out of service, letting it cool down from service to room temperatures. The day after, plant personnel realized that all the radiant coils in the furnace suffered cracking, leaving the furnace completely useless (Fig. 1).

Fig. 1. Failed tubes within the furnace after emergency stop.
