# Root cause analysis of the fracture of a sonar window caused by hydrostatic, hydrodynamic, and transient forces around a ship

Hyung-Suk Han\*, Kyung-Hyun Lee

Naval System Research Team, Busan Center, Defense Agency for Technology and Quality, 525-2, Gwangan 1 dong, Busan, Republic of Korea

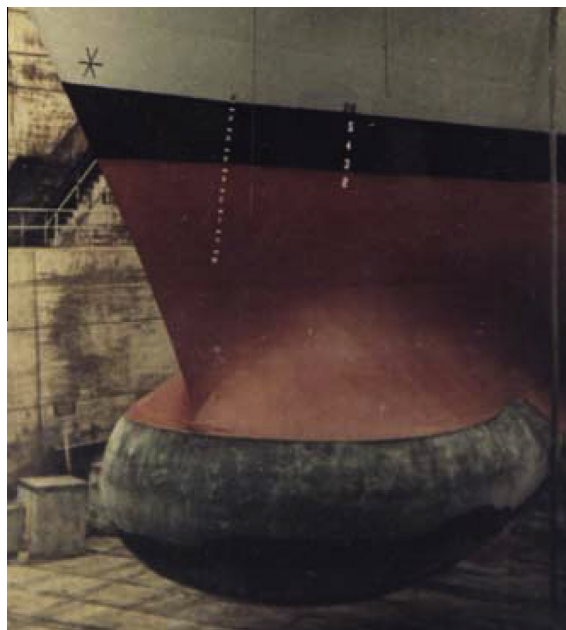
The sonar system of naval vessels is important to confer stealth capability. Recently, these systems have been installed at the bulbous bow of frigates. The bulbous bow is exposed to hydrodynamic forces, such as drag, in addition to slamming and impact forces caused by submerged foreign objects. Fig. 1 shows a sonar window installed to protect against these kinds of transient forces.

Fig. 1. Example of the sonar dome window.
