# Corrosion of carbon steel caustic header in the presence of chloride ions

Anwar Ul-Hamid \*, Hani M Tawancy

Caustic soda produced in caustic cells at a petrochemical plant was loaded into a crude tank by means of a caustic header line made of plain carbon steel. After a fraction of expected service life, the header was severely corroded. Scanning electron microscopy (SEM) coupled with energy dispersive X-ray spectroscopy (EDS) and X-ray diffraction (XRD) was used to identify the material and the corrosion product. Metallurgical evaluation suggested that the mode of failure was localized attack by chlorine and/or hydrochloric acid at pipe connections (flanges) where concentrated solutions could accumulate. Most evidence pointed out that the failure resulted from corrosion attack due to condensation of hydrochloric acid. Misalignment of the pipe at the flange led to cold work which is also thought to accelerate the corrosion rate. It was recommended to consider a better pipe alignment practice as well as the addition of an inhibitor as a short-term solution. Since the piping system was used close to the critical operating conditions, it was recommended as a long-term solution to

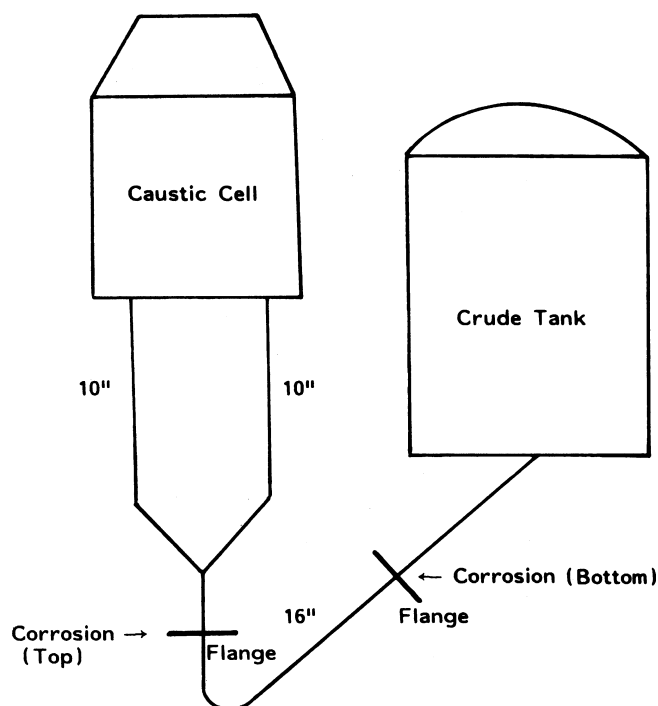
After a short period of usage, severe corrosion occurred particularly concentrated at two locations of the 16 in. header. At the top section, corrosion initiated in the flange and extended about 1.5 m into the pipe as illustrated in Fig. 1. However, at the bottom section, corrosion occurred in the flange only. Four sections of the failed pipe/flange were evaluated as described below:

Fig. 1. Schematic illustration of the caustic cell and the locations of corrosion attack.
