The prevalent motor bearing premature failures due to the high frequency electric current passage

William Liu ^{*}

Industrial Services (NDT & Materials), SGS New Zealand Ltd., Auckland, New Zealand

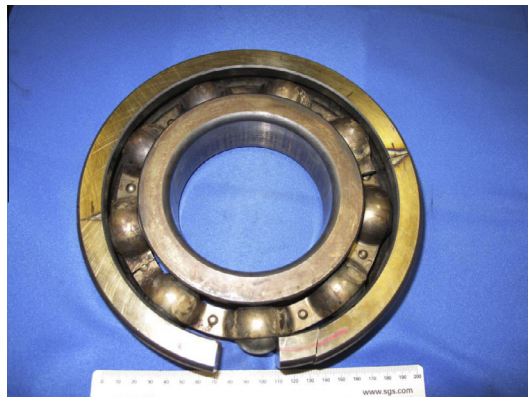
Visual inspection found that the bearing grease had been hardened or partially solidified. The bearing surfaces had been deposited with a brown film. From the symptoms of the brown deposit and the grease hardening, bearing failures due to the high frequency electric current passage was certain. Hence, the failed bearings can be applied in researching the fundamental failure mechanism.

Fig. 1. The failed DE bearing covering with the brown deposit.
