Engineering Failure Analysis

Steel roofing disaster and the effect of the failure of butt joints

This article scrutinises the causes of a disaster of a pitched roof construction made of welded plate girders. The girder construction elements were assembled with bolted butt joints. The roofing was made of a folded sheet supported by steel purlins that transferred the load onto welded plate girders. The purlins had no roof bracings. In the analysed case, several days of abundant snowfall preceded the failure that caused a collapse of the roof of a production hall. The investigations that followed confirmed that the collapse started with the cracking of the bolts used to centrally join the roof girders. In the course of the analyses and calculations, it was established that the main cause of the disaster lay in a faulty design of the butt joints between the segments of the steel plate girders. Another factor having impact on the failure was the numerous mistakes in the design and fitting of the steel purlins. The excessive snowfalls were not the main cause of the disaster but were only an additional one. The article also provides a concept for the reconstruction of the damaged buildi

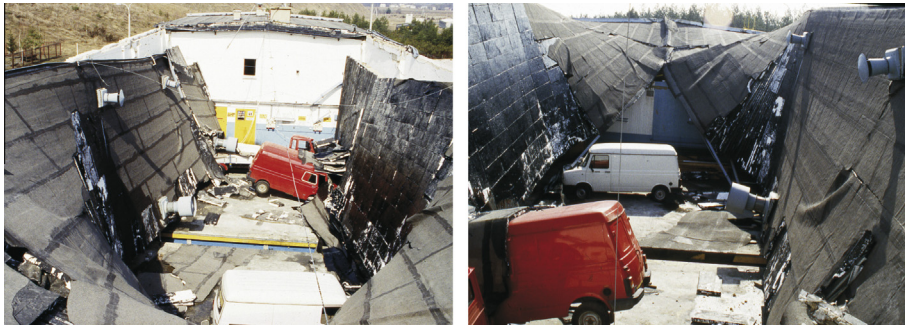
Abundant snowfalls have often been identified as a common indirect cause of roofing failures throughout Europe. The average snow depths frequently exceed the values stipulated in the current construction standards [1], leading to emergency situations or even to construction failures in many buildings, e.g., the collapse described by Biegus and Rykaluk [2]. In the analysed case, several days of snowfall with temperatures of approximately 0 °C caused the collapse of the steel roofing of a production hall belonging to an industrial plant located in Poland, central Europe. Because the catastrophe occurred at night, there were no casualties and nobody was hurt. An overview of the roof construction damage is shown in Fig. 1.

Fig. 1. Overview of the collapsed roofing construction.

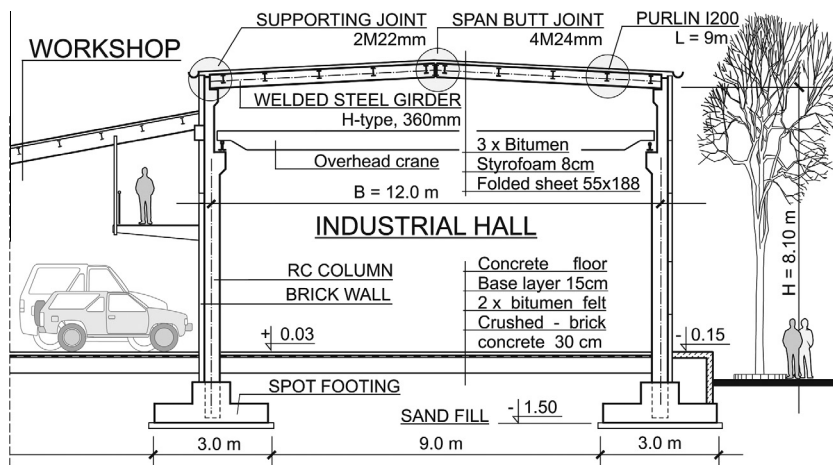
Fig. 2. Cross-section of the industrial hall and the arrangement of the structural elements.
