Failure of Chauras bridge

Harshad Subhashrao Birajdar, Pabitra Ranjan Maiti, Pramod Kumar Singh*

Department of Civil Engineering, IIT (BHU), Varanasi, UP 221005, India

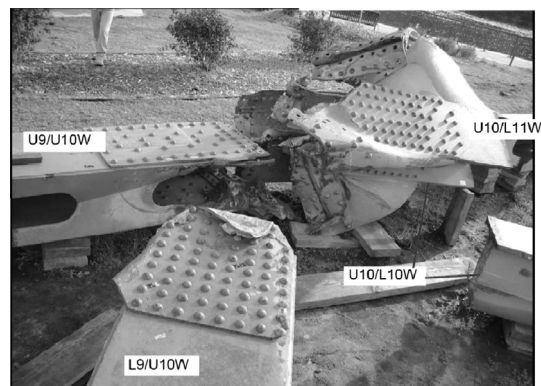
All joints of the bridge were connected by 1 inch thick gusset plates, except top chord joint U10, where half inch thick gusset plates were used (Fig. 1) [4]. Investigation and Finite Element analysis by many researchers concluded that, the undersized gusset plate at joint U10 was the cause of catastrophic and sudden failure.

Fig. 1. Failure of gusset plate at U10.

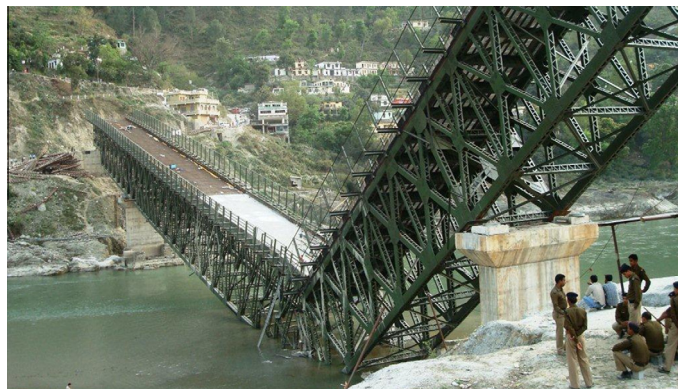
Failure of 190 m long Chauras Bridge in Uttarakhand, India, which was a three span (40 m + 110 m + 40 m) continuous deck type truss bridge, took place during casting of the deck slab (Fig. 2). The bridge was proposed to connect two cities namely, Srinagar on left bank and Chauras on right bank of the river Alakhnanda. After launching of the steel truss on two piers and two abutments, casting of deck slab was initiated on 24.03.2012 at 11.00 AM from mid portion of the 110 m span of the bridge towards right pier. During deck slab concreting, when concrete was placed in 52.5 m length from middle of the 110 m span towards right pier, bridge suddenly collapsed claiming six lives with it (Fig. 2).

Fig. 2. Failure of Chauras bridge during casting of deck slab.
