Root cause analysis of stress corrosion at tube-to-tubesheet joints of a waste heat boiler

Leakage at the tube-to-tubesheet joints occurred in a waste heat boiler. The mode and the root cause of the failure were investigated by chemical composition analysis of the tube material, metallographic structure and crack observation, and corrosion product analysis of the damaged tubes, as well as the operation condition examination of the waste heat boiler. Results revealed that failure of the tubes occurred due to the stress corrosion cracking (SCC), which was caused by tensile stress and chloride-buildup in the narrow and long gap between the tube and tubesheet hole. The gap formation was further analyzed by comparison of the minimum expansion pressure from the common formula provided by the manufacturer, with that from finite element method computations. It is found that the minimum expansion pressure used in manufacture is small and cannot eliminate the initial gap. Meanwhile, the enrichment of chloride in the gap was briefly discussed.

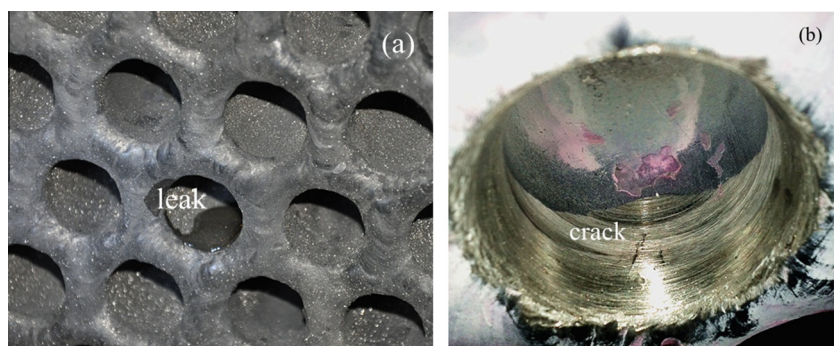
According to the site survey, the leakage was confined to the region within the joint between the tube and tubesheet, as shown in Fig. 1(a). No crack was found on the inner surface of the tube at the rolled end with the naked eye. Cracks were observed after being penetrant inspected and polished, as shown in Fig. 1(b). The width of the cracks increases with the depth increasing.

Fig. 1. Leakage position and crack appearance on the tube of the water-gas waste heat boiler. (a) leakage position and (b) crack appearance.
