Failure analysis on abnormal wall thinning of heat-transfer titanium tubes of condensers in nuclear power plant Part II: Erosion and cavitation corrosion

Fei-Jun Chen, Cheng Yao, Zhen-Guo Yang*

Department of Materials Science, Fudan University, Shanghai 200433, PR China

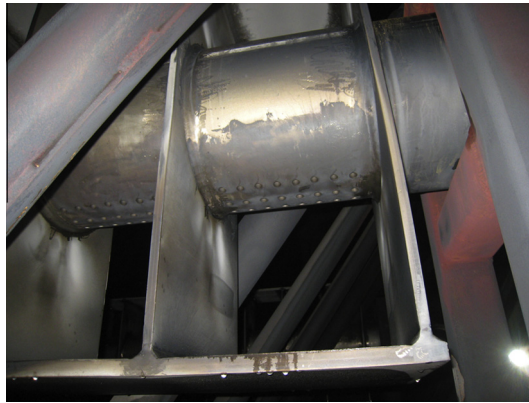
Fig. 1. Bypass pipes.

which were designed for shock mitigation of high pressure steam during start and stop (Fig. 1). As illustrated by the tube arrangement diagram shown in Fig. 2, within the tower-like structure of 9922 heat transfer titanium tubes in each condenser, samples in Part II are located at the tower shoulder under the bypass pipes while the samples we analyzed in Part I [1] were all in the lower part of the tower. So we decided that these special tubes must tell another failure story, which was discussed in the current Part II of the failure analysis.

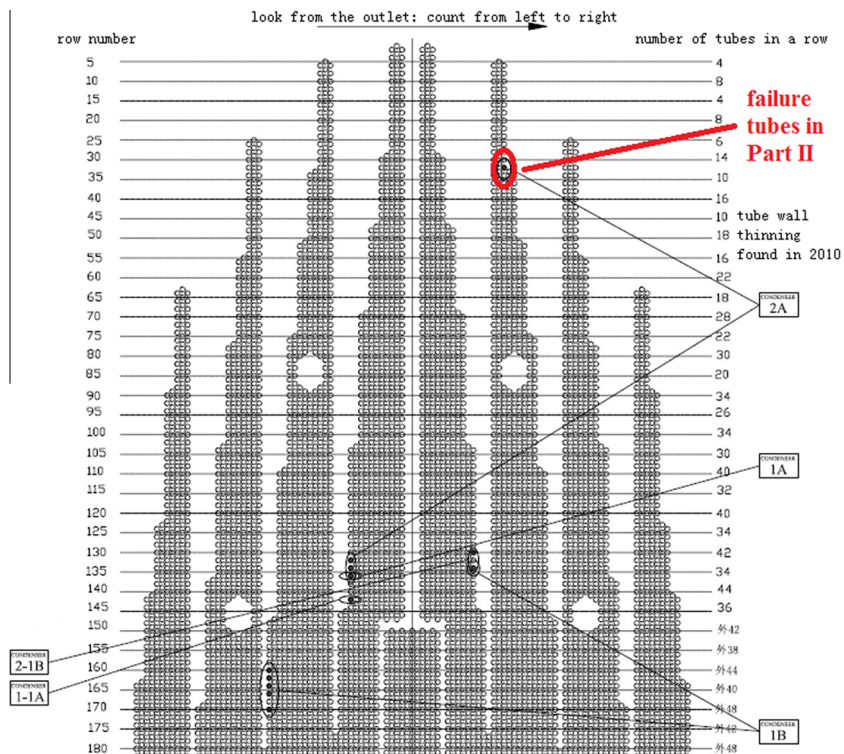
Fig. 2. Schematic illustration of the location of failure tubes in Part II in the condenser.
